Frost fracturing of riprap armour stones in Sporðalda Dam, Iceland.

B. J. Björnsson,
 Studull Consulting, Iceland, bjb@studull.is

L. Skúlason,
 Hnit Engineering, Iceland, leifur@hnit.is

J. S. Úlfarsson
 Landsvirkjun Power, Iceland, Jon.Smari.Ulfarsson@lvp.is

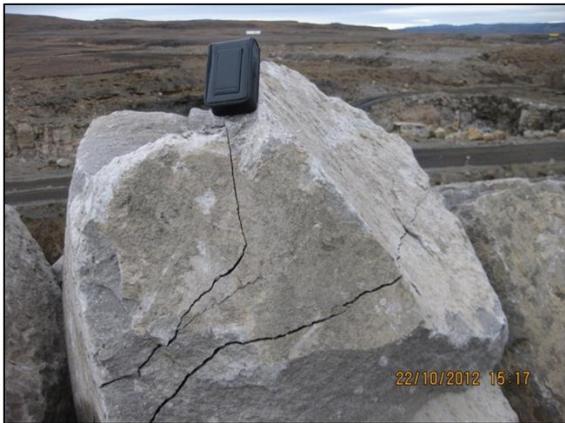
Once the filter and shell material problems had been sorted out during the summer of 2012, the dam construction proceeded as foreseen until fall 2012. Considerations of possible floods required that the dam had to be filled up to an elevation of 333 m a.s.l. in 2012. On October 22nd 2012 following a weekend break, during which the temperature in the area reached -5 °C for the first time that autumn, it was noted that considerable portion the riprap stones placed during the previous two weeks was fractured. Figure 6 shows an example of this. During that particular weekend the stones in the riprap may have experienced one or two frost/thaw cycles.

Figure 6. Fractured riprap stone.

Examination of the rip rap already placed in the Dam in late October 2012 showed that the riprap that had been placed in the preceding one or two weeks was extensively fractured. This was the case for station 100-350 along the dam axes in the NW dam. Riprap placed during the summer and early autumn at station 400–700 was largely intact. The percentage of fractured stones was determined at six locations. Figure 7 shows the result of this investigation. At each

Also in 2013 the Contractor was requested to finish blasting of armour stones before the end of September before temperatures dropped to below freezing and stockpile riprap stones for three weeks before placing in the Dam. This however did not quite work out and blasting of riprap stones continued into the winter period. The riprap stones were generally stockpiled for one or two weeks. As a result, some broken riprap stones are to be found in the wave protection.

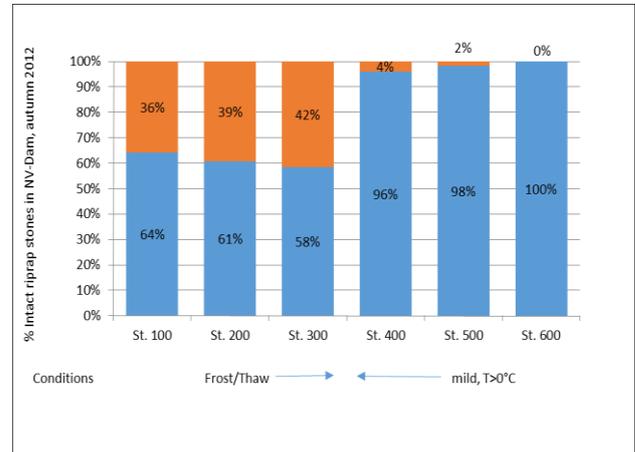
location 60-80 stones were examined. The riprap material in all cases came from the basaltic lava flow formation and appeared to be similar in every respect. The only difference was that the ambient temperature had fallen below 0°C shortly after the rip rap at station 100-350 was placed.

Figure 7. Percentage of intact riprap stones in the NW Dam in autumn 2012

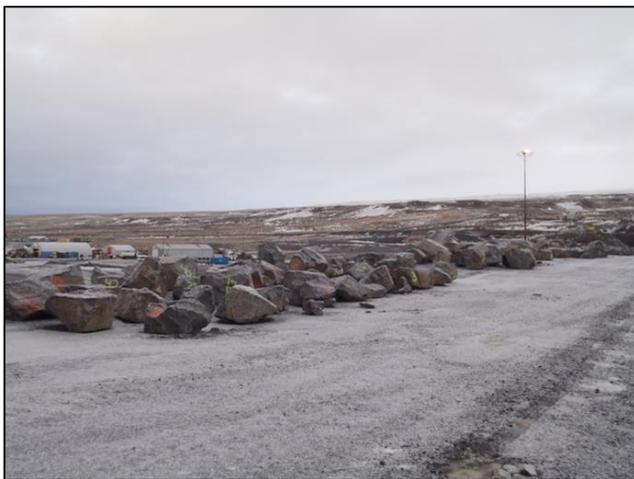
Table 1 shows the quarries, number of stones from each source, date of blasting, date of first exposure to frost, date of transport to test site and first examination of stones. The test site was selected on top of the dam fill so that snow would not cover the stones. Figures 8 to 11 show the test site and stones in the test.

Figure 8. Site test of riprap stones

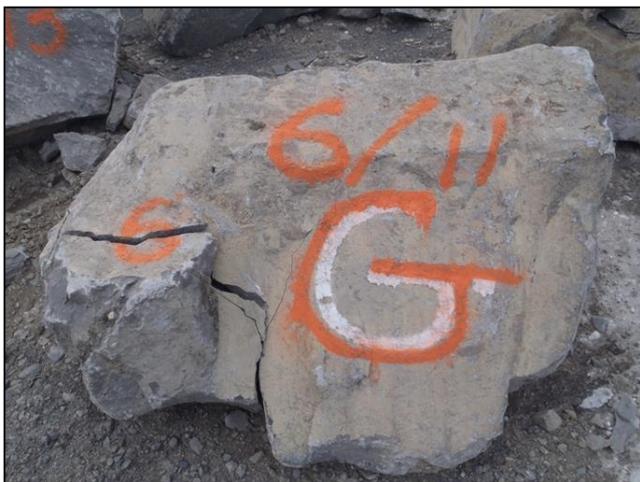
Figure 9. Fractured riprap stone in the site test

The fracture surfaces are in many cases completely fresh and don't appear to follow pre-existing weaknesses in the rock.

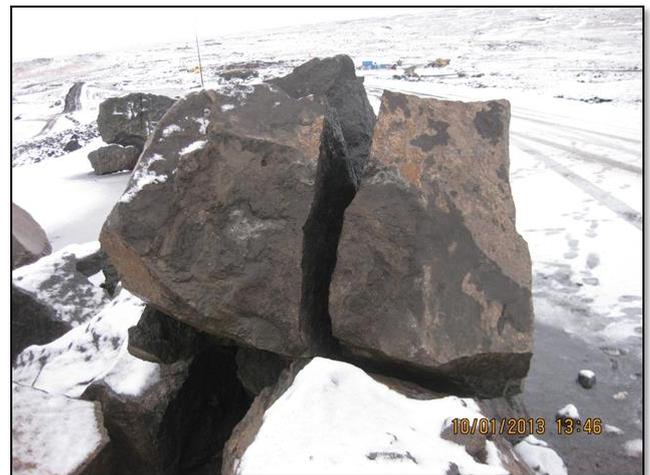
Figure 10. Another fractured riprap stone in the site test

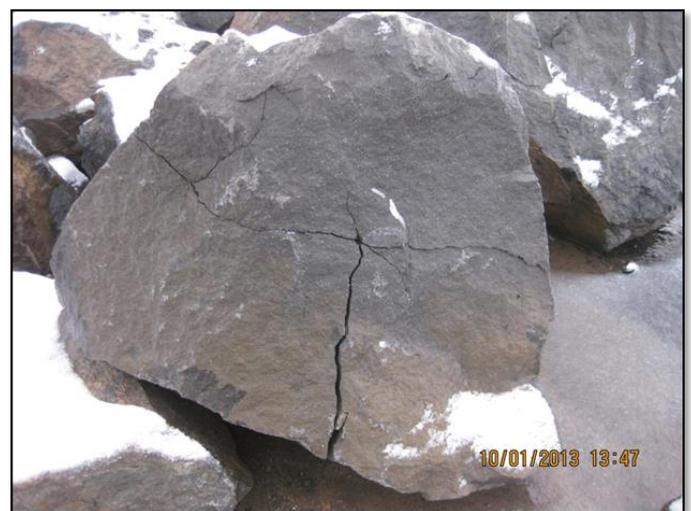
Figure 11. Fractured riprap stone in site test

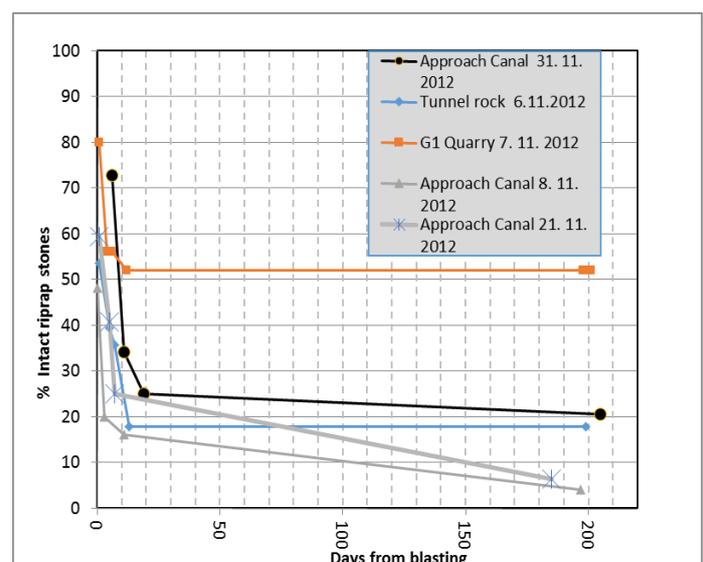
The riprap stones in the test were examined three or four times in the period from November to December 2012 and again in summer 2013. Figure 12 shows the results. It appeared that the stones started cracking following first exposure to mild frost (-5°C). Most of the fracturing took place within the first 10 days. The number of freeze/thaw cycles does not appear to have a significant effect on the progress of fracturing. The degree of fracturing seemed to be independent of stone size.

Figure 12. Results of site investigation of riprap stones.

Further surveying of the test stones could have revealed if the fracturing all takes all place within the first month or not. However, the test stones became covered with ice and snow and could not be examined further until next spring. The rock from quarry G-1 appears to have a higher resistance to cracking than rock from other sources in the area. The rock in quarry G1 may not have been saturated at the time of blasting while rock blasted from the Approach Canal and from the Headrace tunnel were probably saturated.

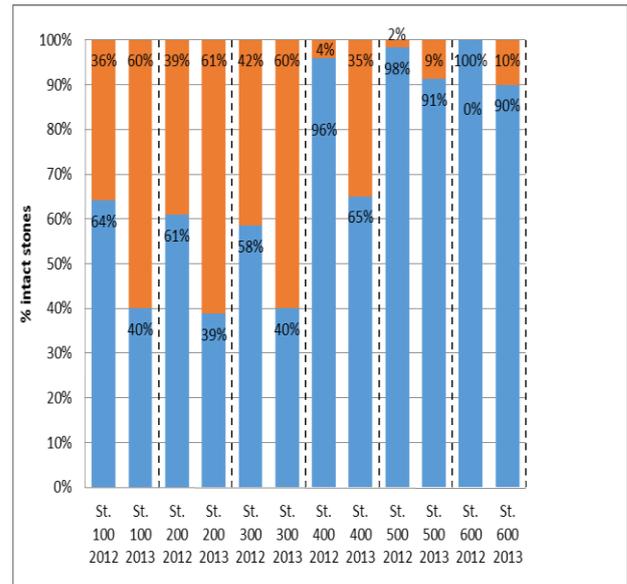
In June of 2013 when snow had disappeared from the riprap already placed in the Dam the counting of fractured riprap stones was repeated in the same locations as in November 2012, counting essentially the same stones as before. The results are shown in Figure 13.

Comparing the results from 2012 and 2013 reveals that the proportion of fractured rip rap stones that were placed during the summer of 2012 increased to 10 % at station 600 and 500.

For rip rap stones placed at stations 100-300 the fracturing increased considerably. Only 40 % were unfractured in June 2013. The 20 % increase of fractured rip rap stones at stations 100 -300 shows that the initial fracturing was not over by the end of October 2012. At stations 500 to 600 the number of intact stones was about 90 % which is similar to observations from other dams in Iceland. The results at station 400 do not fit into either of the above classes and is unexplained.

Figure 13. Proportion of fractured rip rap stones along the dam axes in 2012 and 2013.

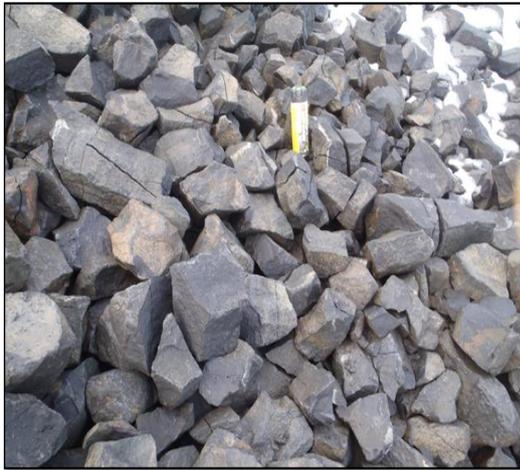
As explained earlier the slope protection materials (20-40 cm) and the coarser filter (0-20 cm) were obtained from the cube jointed Sporðalda basalt formation. On that dreadful autumn day in 2012 when the fractured riprap was discovered it was also found that the slope protection material was extensively fractured.

Figures 14 and 15 show this. This was serious not only for the upstream slope protection but also because slope protection material is underlying the riprap wave protection and filter criteria had to be fulfilled. Cube jointed basalt has not commonly been used for damfill materials in Iceland. Parts of many quarries in basaltic material contain some cube jointed basalt. Fracturing due to frost has not been noticed as far as the authors know. Cube jointed basalt with smaller cubes than found at the Sporðalda dam has been used in bearing courses for roads with good results. Therefore, extensive frost fracturing of this material was unexpected.

Figure 14. Frost fractured slope protection materials in autumn 2012.

The use of cube jointed basalt as a slope protection material (20-40 cm) on the upstream slope was discontinued. Instead material processed from tunnel spoil was used. This material had been exposed to several freeze/thaw cycles.

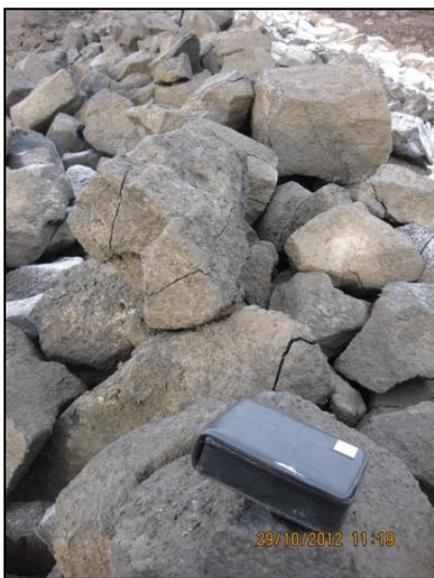
Figure 15. Frost fractured slope protection materials in autumn 2012.

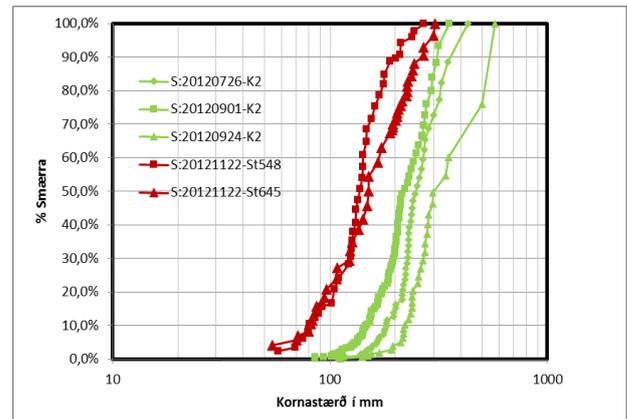
Figure 16 shows a comparison between fractured and unfractured slope protection material (20-40 cm) from cube jointed basalt. The d_{50} (average grainsize) of the unfractured samples taken during the summer is reduced from approximately 250 mm to 150 mm in a sample taken from the dam in late November. The fractured material still fits the originally specified gradation for slope protection.

Figure 16. Grain size of frost fractured and unfractured fill from cube jointed basalt. K2: Unfractured fill from K2 quarry, St548 and St645, frost fractured material from dam.

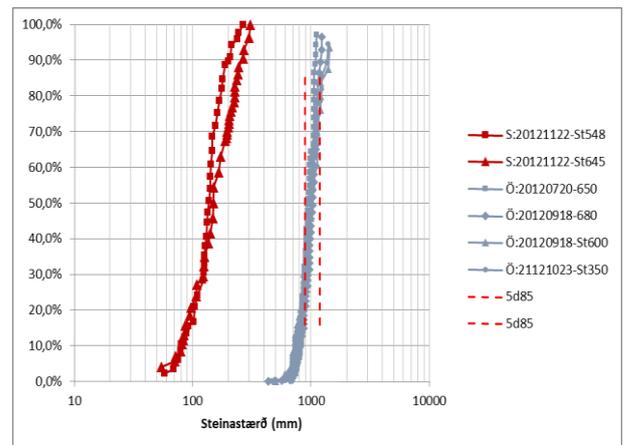
Figure 17 shows a comparison between the grain size of the fractured slope protection material and measurement of riprap stone sizes from 2012. As can be deduced from Figure 16 classical filter criteria for the riprap stones is just about fulfilled between the riprap and the slope protection

Figure 17. Comparison between the grain size of frost fractured slope protection material and measurement of riprap stone sizes in 2012.
