Large scale driving of concrete piles in stiff to very stiff clay

Thomas Sandene

Norwegian Geotechnical Institute, Norway, thomas.sandene@ngi.no

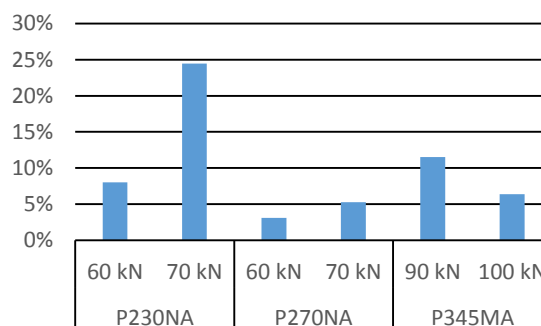
Figure 8 shows the distribution of broken piles by cross section and hammer size. The most obvious result is the combination of P230NA piles and 70 kN, which proved to be significantly unfavourable. Driving of the smallest piles with this hammer was therefore stopped completely as soon as the broken piles percentage was identified to be that high compared with other combinations. In general, P230NA and P345MA piles proved to be more difficult with respect to pile breakage compared with P270NA piles.

Figure 8: Percentage of broken piles by cross section and hammer size

Another observation from Figure 8 is the fact that the combination of P270NA piles and 60

kN hammer weight was the best combination with respect to number of broken piles. This was the same combination that was used during test-driving, and one could therefore say that the test-driving setup was not able to capture some difficult aspects of the pile-driving job at the site.

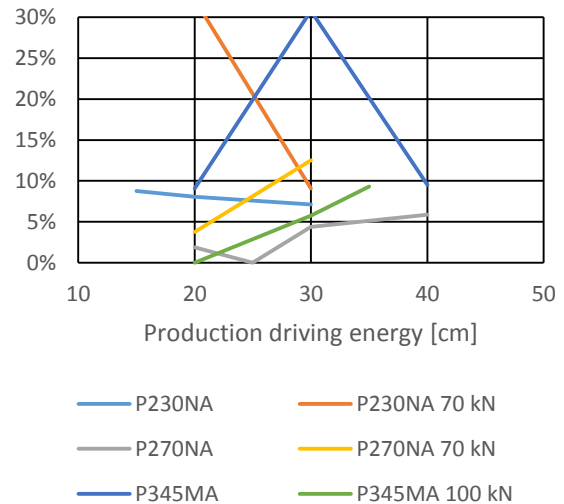
Figure 9 illustrates the percentage of broken piles by driving energy. Combinations with fewer than 10 piles (ref. Table 2) are left out of the diagram. The hammer-pile-combinations P230NA-70 kN and P345MA-90 kN obviously stand out as generally unfavourable. For other combinations,

reducing the energy during driving clearly reduces the number of broken piles. Reducing the energy increases the number of blows required to get the pile down to bearing layers, increasing the sum of dynamic loading on the pile during installation. From reduced energy also follows reduced stresses in the pile during driving, and the reduced stresses means less chance of the pile breaking over time.

Figure 9: Percentage of broken piles by cross section, hammer size and driving energy

The effect was especially significant when reducing energy from 30 to 20 cm for P270NA piles driven with 70 kN hammer. This combination was used for about 1/3 of the total number of piles in the project (Table 1).

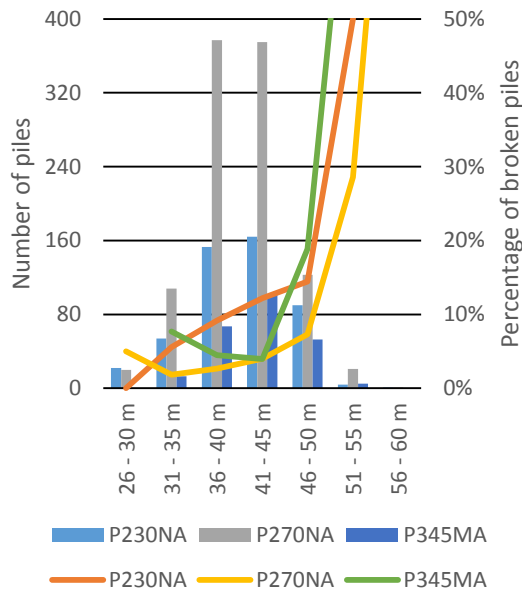
The columns in Figure 10 show an overview of the total number of piles for each cross section and total pile length interval. The graph lines illustrate the percentage of broken piles for the corresponding cross section and total pile length interval.

According to figure 9, the number of broken piles increases significantly when the total pile length increases over about 46-50 m. Almost all P230NA and P345MA piles and about 30 % of P270NA piles longer than 50 m were broken. About 15 to 20 % of P230NA and P345MA piles and 7 % of P270NA piles between 46 to 50 m long were broken.

Figure 10: Number of piles and broken piles by pile length

An increasing pile length increases the risk of some kind of unfavourable curvature of the pile, increasing the risk of breakage. The increased length also comes with an increase in total number of blows and cycles of dynamic stresses.

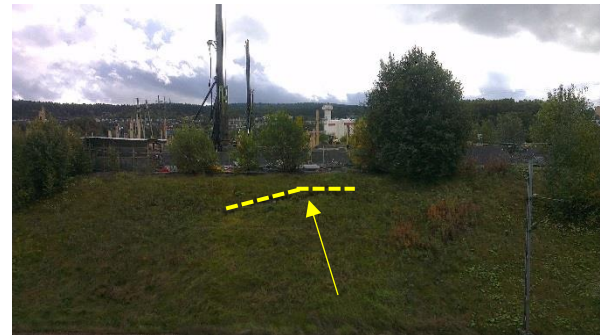
In September 2012, after a heavy rainfall, surface cracks were observed in the slope towards the railway line. The appearance of the crack coincided with pile driving near the top of the slope. Figure 11 shows a picture taken from the other side of the railway cut, with the pile driving cranes working in the background.

Figure 11: Surface crack in slope (marked with yellow dashed line)

Even shallow surface slides could cause concerns regarding operation of the railway line, and driving of concrete piles near the slope was stopped immediately. The slope was instrumented with electronic piezometers and inclinometer casing. The piezometers measured a very high pore pressure, with a magnitude in the order of the same as the vertical overburden (meaning that the effective stresses were very small). Inclinometer measurements were done with short time intervals for the first period of time after installation, but indicated no significant movement in the slope.

For the slope to have a sufficient factor of safety in a permanent situation, the top couple of meters of the slope was planned to be removed and replaced by lightweight fill material. This operation was expedited to increase the safety during the construction phase. Drilled steel core piles replaced the concrete piles within a safety zone from the slope, in order to prevent further build-up of horizontal stresses and pore pressures. The drilled steel core piles were installed as gently as possible (low air pressure and drill speed)

to reduce the risk of further set up of excess pore pressure.
