Guldborgsund Tunnel. Operation of tunnel and drained ramps

ABSTRACT

The tunnel at Guldborgsund is an immersed tunnel connecting the Danish islands Lolland and Falster. The tunnel is a twin tube road tunnel. The tunnel is approximately 500 m long including portal structures, and has approx. 400 m open ramp on each side of the tunnel. The tunnel is owned and administered by the Danish Road Directorate.

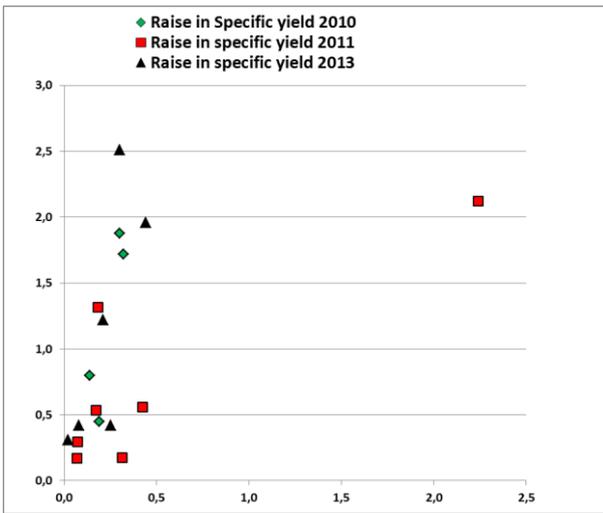
Very different improvements were identified, but in general improvement above 100-200 % was seen. Improvements in an selected amount of wells are shown in figure 1.4, where "specific capacity" after treatment are shown vs. "specific capacity" before treatment.

Few treatments have shown only little improvements measured in relief yields but the general effect is seen in lowering of water level in the ramp.

Figure 1.4 Results of acid treatment. Specific capacity after treatment vs. specific capacity before treatment. Units are $m^3/hour/m$ lowering.

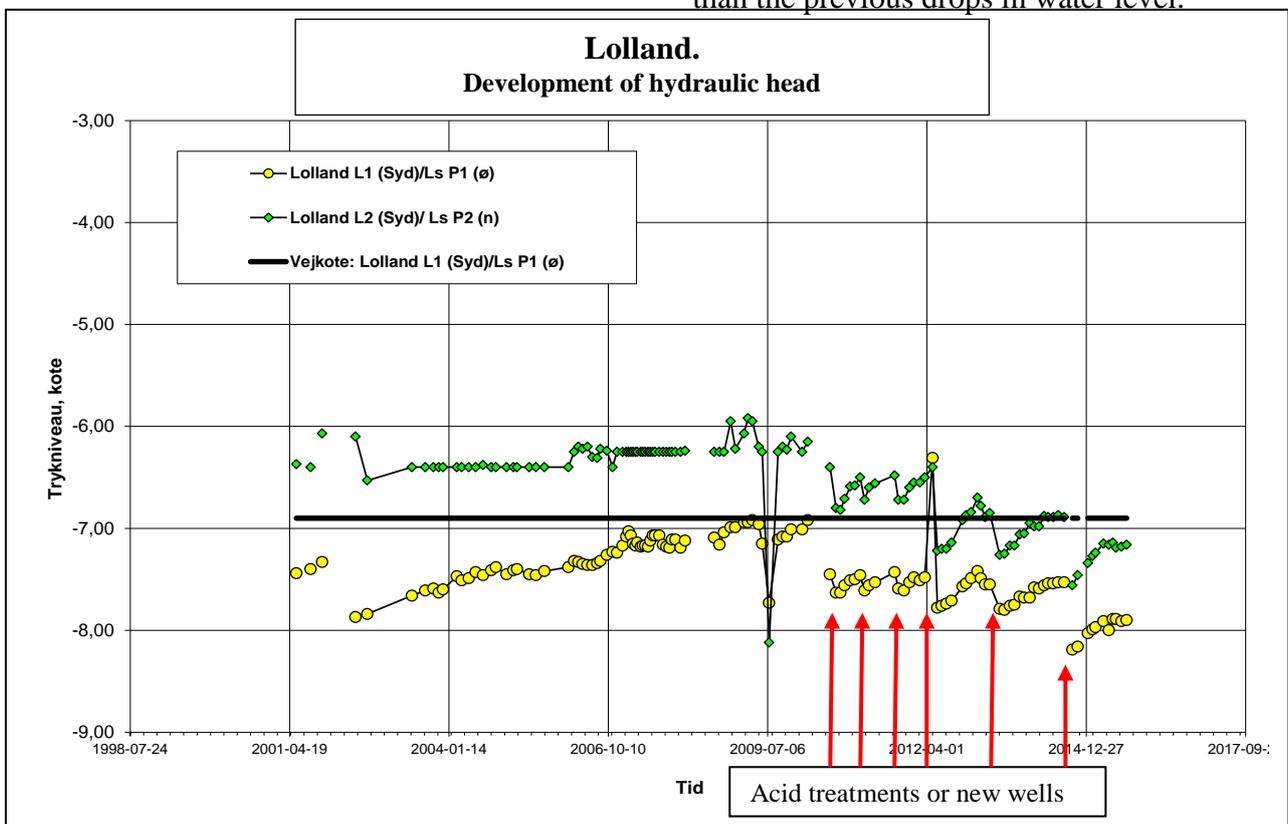
Figure 1.5. The typical variation is a raise of water level of 3-5 cm per month. Each year 8-10 wells are chosen for acid treatment and bringing the water level down corresponding to the degeneration. Last shown drop on figure 1.4 is related to acid treatment of all 5 wells in the portal reservoir close to L1 and L2 and the drop in water level here is higher than the previous drops in water level.

Figure 1.5 Lolland. Overview of water levels in 2 monitoring wells.

Access challenges to these wells gives reasons to take them all in one sequence instead of 1-2 each year. The yellow dots in Figure 1.5 represent water level in upper part of chalk and the green dots represent waterlevels in the chalk 5 m lower. It might not verify the presence of increasing permeability by depth, but it verifies the presents of several flow zones in the chalk. On Falster the clay till layer is present from top chalk to base of road foundation. Here it is accepted that the water level around the deepest part at the entrance to the portal structure is above surface and observation wells here are closed to avoid relief of water. The wells are sealed and are being monitored by manometer. The water level here is monitored and managed in order to have a reasonable uplift safety against uplift, but also to avoid upwards gradients above 0.6.

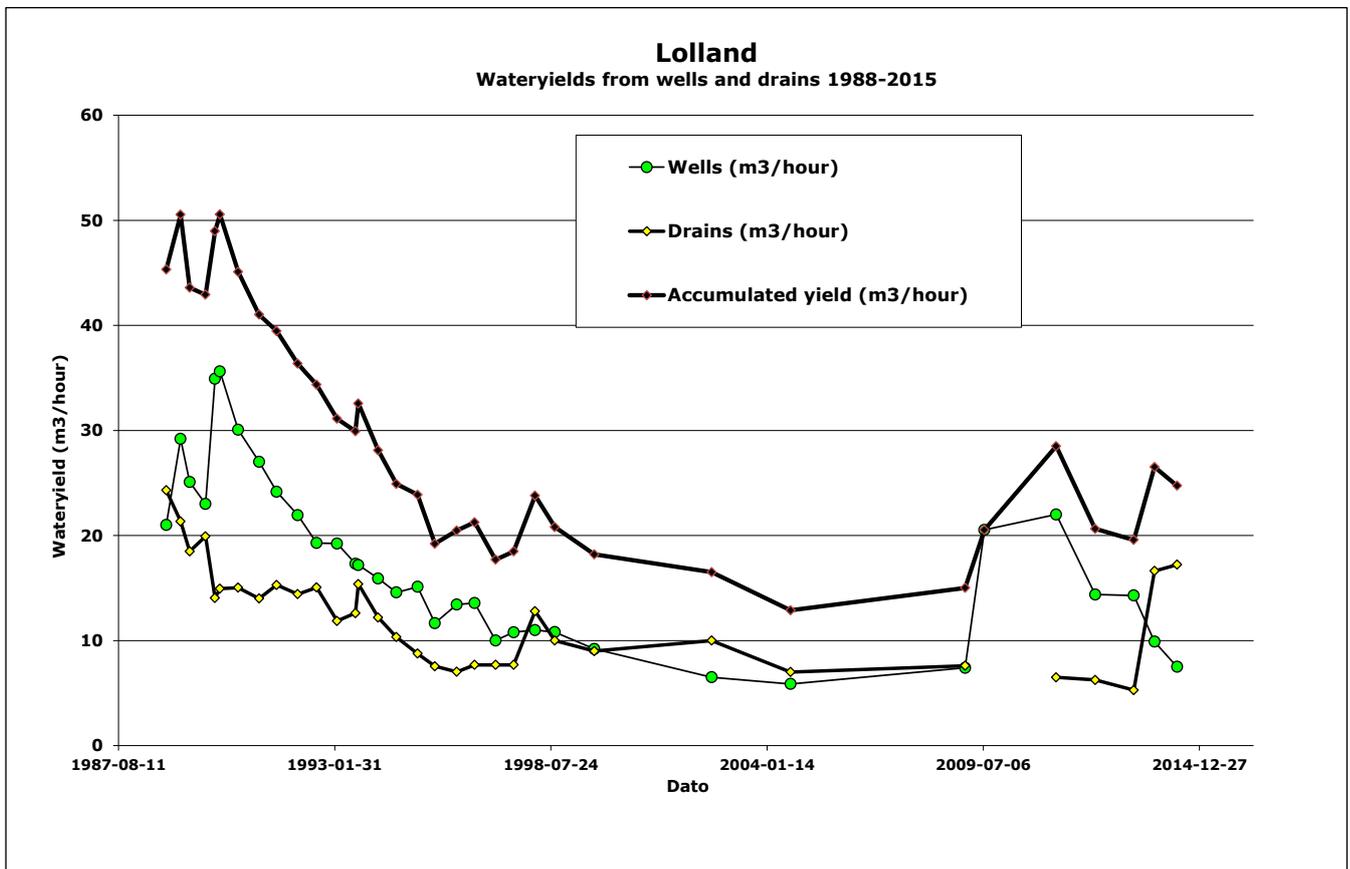
There are only few data available from the initial operation phase and summarized yields from Lolland ramp are shown in Figure 1.6. It is seen that initial relief of groundwater from the wells and drains was approximately 50 m³/hours and dropped in the period up to 2007 to a little below 15 m³ /hour. From 2007 a more regular maintenance of the relief wells started.

As seen on Figure 1.6, the initial relief of groundwater from the wells and drains were 50 m³/hours but are now stabilized on 25 m³/hours. The initial yield on Falster side is not available but today this yield is also around 20-25 m³/hour.

The increase in yields is in general related to the ongoing acid treatment of the wells, but in 2009 it was related to additional 2 wells established to handle the piping area.

Figure 1.6 Yield measurements 1988-2014

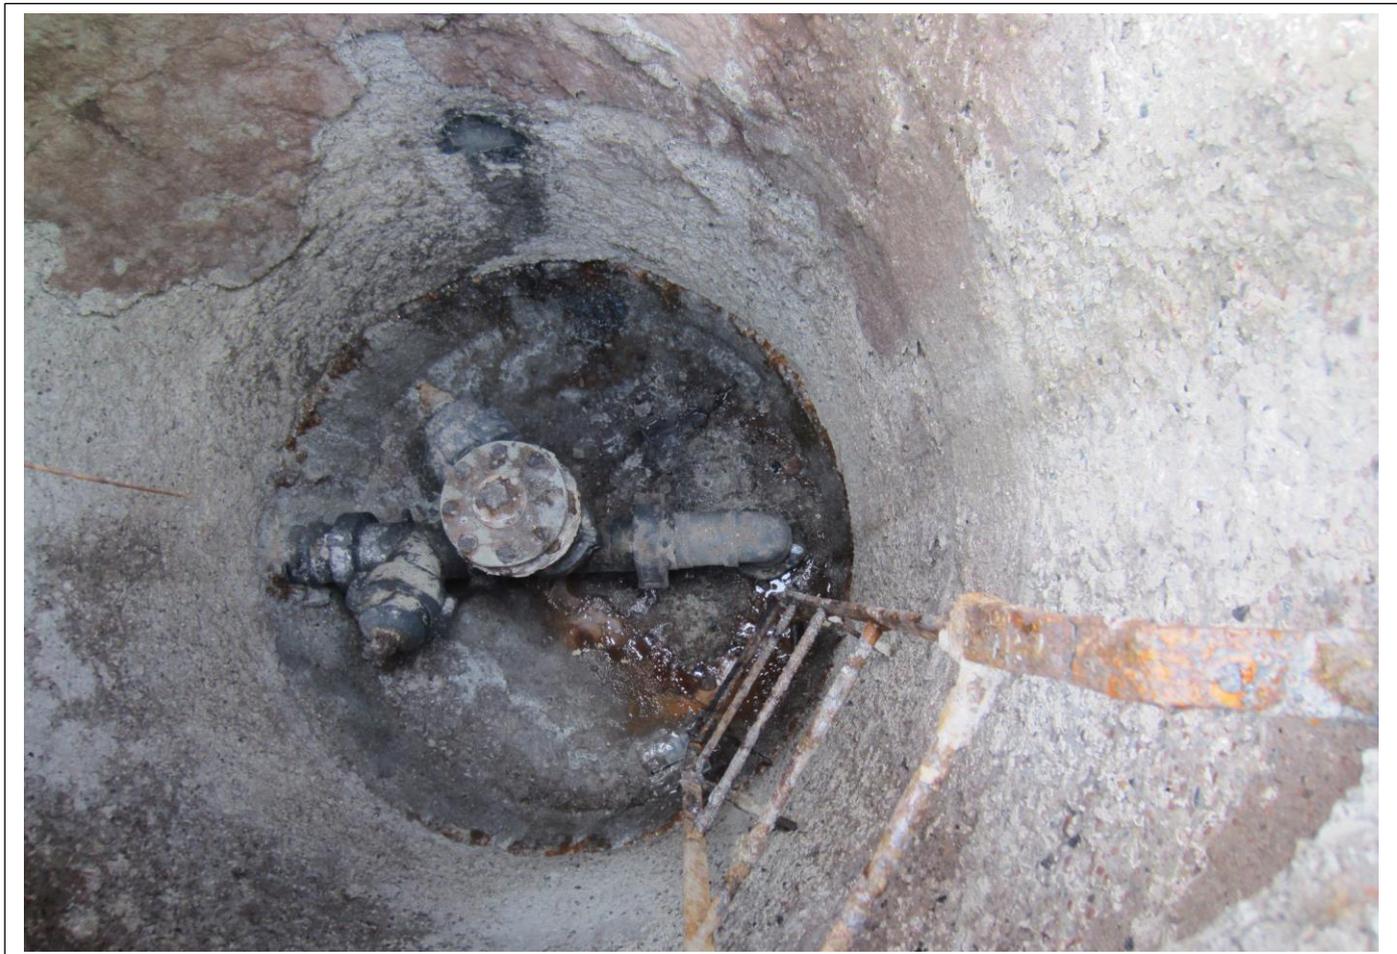
On Lolland the groundwater has a significant content of sulfur, which has led to a chemical attack on parts of the concrete structure (portal reservoir) and the relief wells (installations and concrete protective structures). To prevent concrete deterioration ventilation has been installed in the portal reservoir on Lolland and concrete structures for relief wells have been repaired/ exchanged. On the concrete protection of the relief wells the corrosion is very visible as can be seen on the photo in Figure 1.8.

Figure 1.8 Installation of relief well in concrete ring on ramp at Lolland. Photo T.N. Petri.

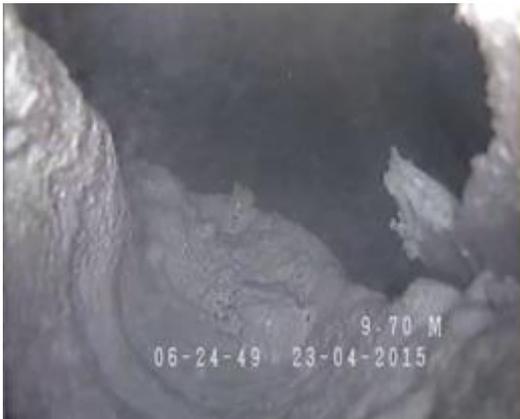
Damage in filter screen: In one well on Lolland filtersand and blue PVC screen parts with slots were airlifted/pumped up from the well during capacity testing of the well before acid treatment. A following video inspection of the well identified a damaged screen, where a significant “handball size” big hole could be seen in bottom. Se Figure 1.9

Figure 1.9 Still picture from well video.

The well has not been mechanically treated since commissioning and it is likely that the hole has been present since establishment. So far no remedial actions have been taken as the situation seems stable in the chalk.

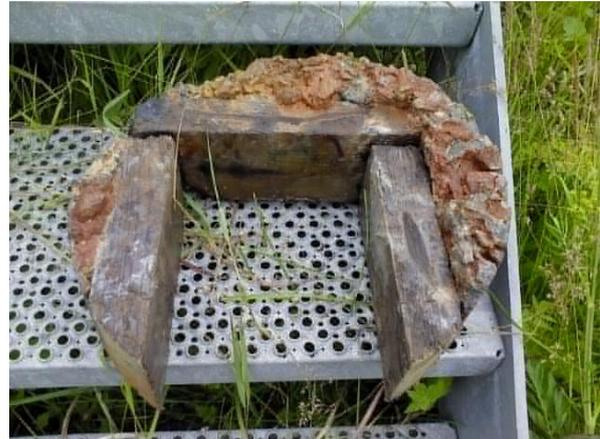
In one of the wells it was identified that the concrete bottom was not able to resist the pressure from the acid treatment and it was found that only a poor thin blinding layer was present in bottom of the concrete protective structure. In the bottom plate of the concrete structure a recess was made by wood allowing the well to be drilled from surface

and the recess could afterwards be sealed. Apparently this was not done. Se photo in Figure 1.10.

Figure 1.10 “Bottom” of well “protection”

Thorough final supervision of all works before commissioning is recommendable as significant deficiencies are registered 28 years after commissioning.
