The Refne landslide, Halden, Norway: case history and use of risk assessment

T. F. Smaavik
NGI, Norway, tone.fallan.smaavik@ngi.no

ABSTRACT

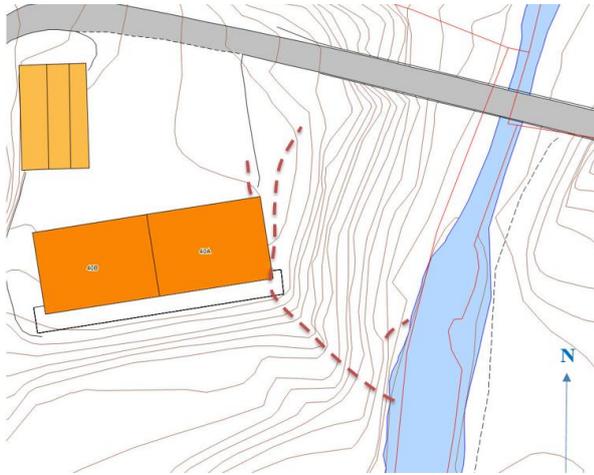
NGI was first contacted by local residents regarding cracks and displacements on top of a 16 m high, steep slope beneath the apartment block. An inspection was carried out by NGI and it was discovered that a large slope instability had developed. The slope had deformed visibly and a continuous crack had developed covering the full width of the slope beneath the apartment block. Along the crack, the slope had a vertical deformation of approx. 0,5-1 m. The southern part of the crack followed a ridge leading down to the Refne stream (Figure 2).

Figure 1 Location of the apartment block and approximate location of cracks in slope. The slope was 16 m high.

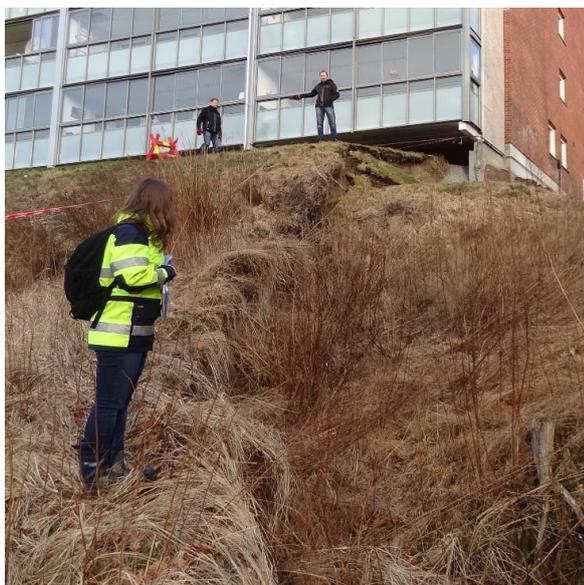
Figure 2 The backscarp of the slide. Vertical deformation 0,5-1 m.

Deformations along the side of the block were approx. 1,5-2 m. The backscarp of the slide coincided with the corner pile of the block partially exposed the corner pile foundation (Figure 3). The pile guided the crack in the way that the direction of the backscarp was forced outside the pile.

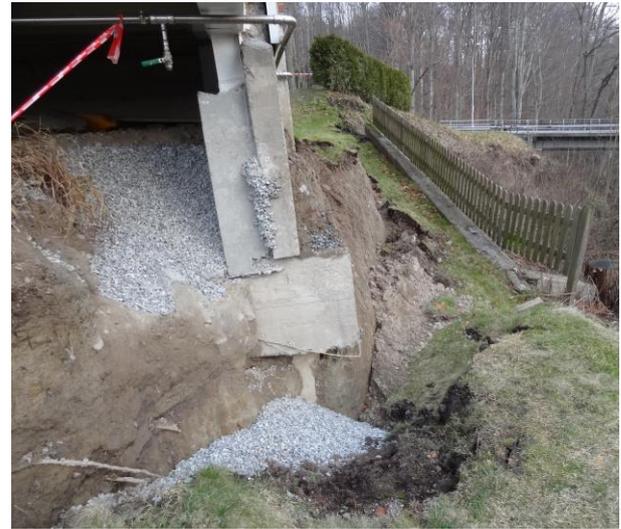
The deformations of the slope had uncovered the corner pile foundation, situated at the brink of the slope (Figures 1, 2 and 3).

Figure 3 Backscarp of the landslide restricted by the pile foundation. Concrete pile supporting the corner foundation visible.

The five story block was built in 1974 on driven concrete pile foundations. A sand fill of approx. 2 m was built at the construction site before the piles were driven (Figure 3). Information from construction workers taking part in the construction work in the 1970s indicated that soft, sensitive clay might have been encountered during installation of piles. Assumptions based on typical building methods, construction drawings from local archives and the geological setting formed the basis for the assessment of the block's sensitivity to ground movements and expected behaviour should any of the foundations fail. The early stage evaluation was that failure in any of the piles closest to the landslide could leave the block uninhabitable.

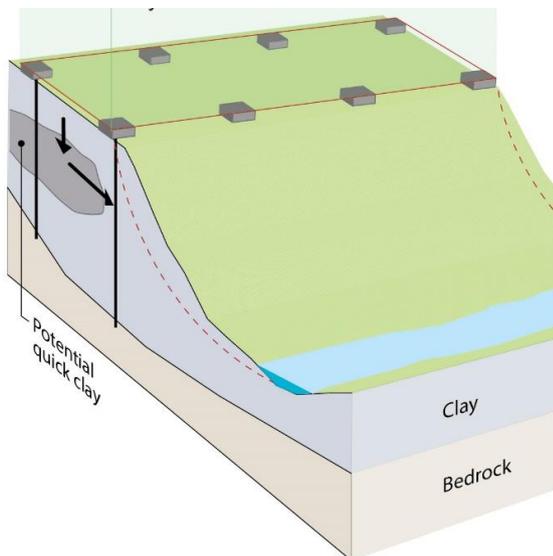
If potential quick clay under the block was to slide, all piles would likely follow the slide, break or buckle (Figure 4). Soundings performed in the first phase of the SI did not indicate quick clay underneath the building, but the scenario could not be eliminated before samples were taken and analysed. However, it was deemed unlikely that quick clay could be exposed as a result of further development of the landslide, thereby triggering a major quick clay landslide involving the building, i.e. the lowest probability class P1 was assigned.

Figure 4 Scenario A - quick clay slide

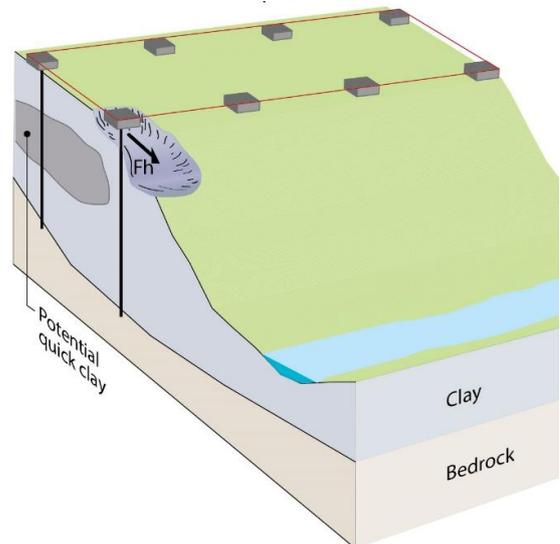
One of the concrete piles under the block was partly exposed by the landslide (Figure 3). A further development of the landslide would increasingly expose the pile, leaving it vulnerable to excessive lateral loading or horizontal displacement (Figure 5). The probability of damage to the corner pile was evaluated to be in the highest probability

class P4, i.e. damage to the pile was expected to occur within 1 year. Further movement of the landslide would certainly be expected in connection with heavy rainfall events.

Figure 5 Scenario B - Damage to corner pile

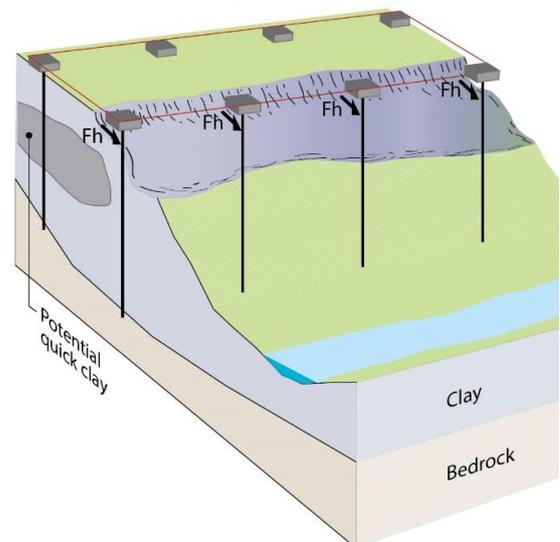
Should the landslide develop along the length of the slope, more of the piles in the pile row closest to the slope could be exposed or affected (Figure 6).

Figure 6 Scenario C - Damage to several piles in 1st row

Due to the orientation of the building not quite parallel to the slope (Figure 1), the distance from the closest piles to the slope edge increases slightly towards the north. This makes a scenario damaging several piles

slightly less probable than damage to the corner pile. For this scenario, the second highest probability class P3 was therefore assigned.

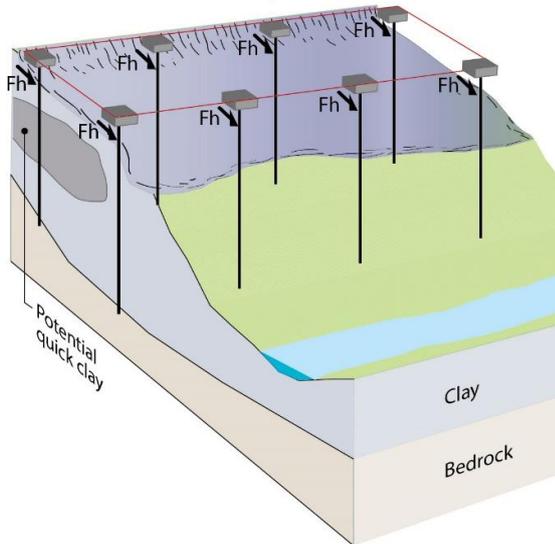
The distance between the rows of piles was approx. 6 m. Based on the SI it was considered less likely that the landslide would develop backwards to that extent and cause direct damage on the piles in the second row (Figure 7), i.e. the second lowest probability class P2 was assigned.

Figure 7 Scenario D - Damage to several piles in 2nd row

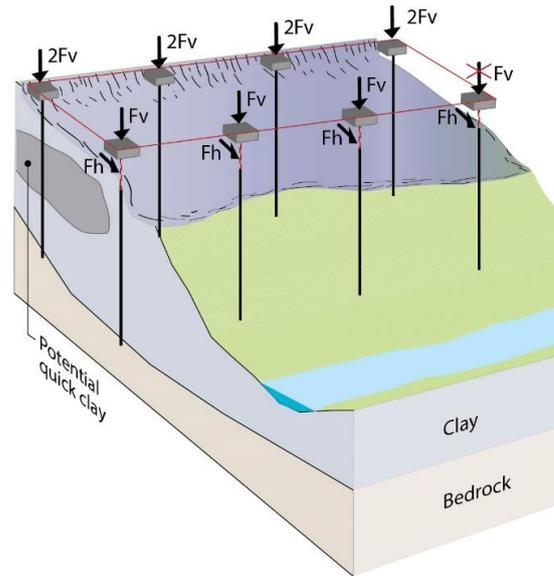
A "domino effect" may occur from redistribution of horizontal and vertical loads. It is a relevant scenario if failure of one or several piles leads to deformations that cause additional load on, and potential failure of, the next row of piles (Figure 8). The second highest probability class P3 was assigned for this scenario.

Figure 8 Scenario E - Domino effect - failure of all piles
