Solutions for Various Obstacles Encountered with Laboratory Piping Tests

Keywords: piping, flume test, backward erosion, dams, levees

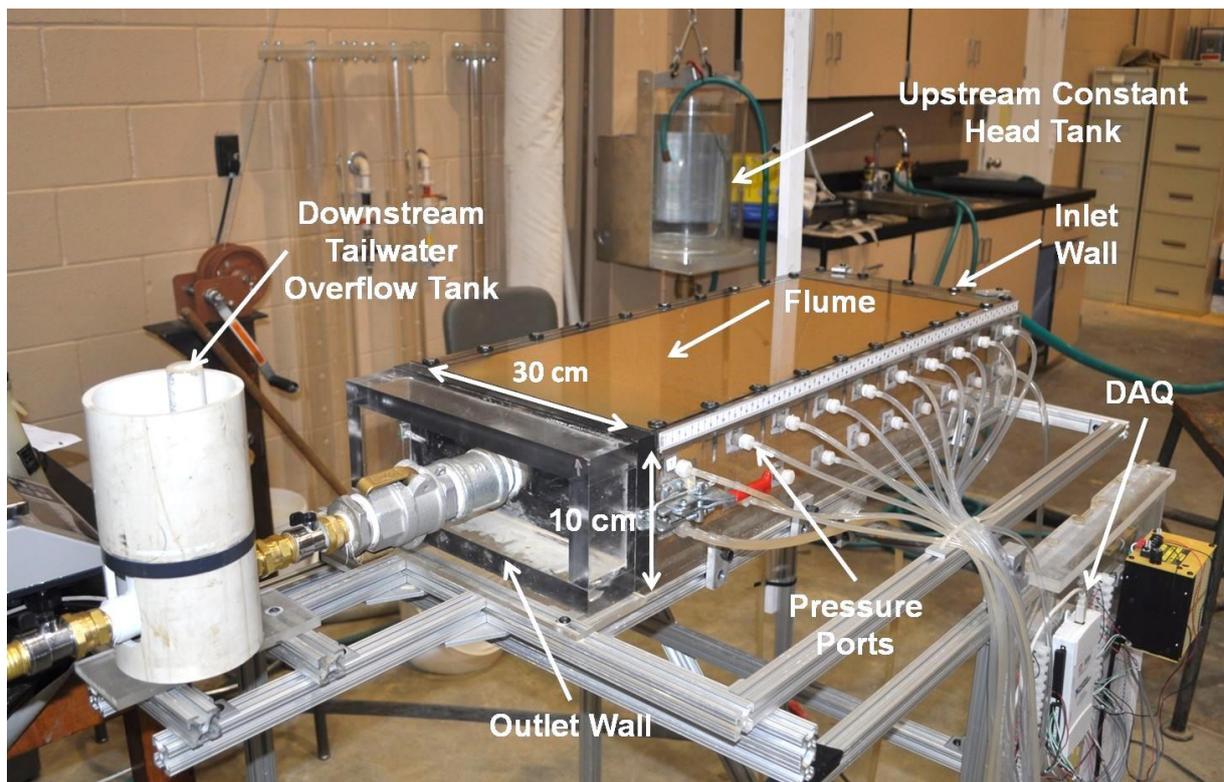
Figure 1. Overview of the small-scale flume and rest of equipment.

A similar experimental study to measure critical horizontal gradients in laboratory flumes was initiated in 2013 at ERDC. A small-scale flume was constructed to test a variety of uniform sands (Figure 1). The

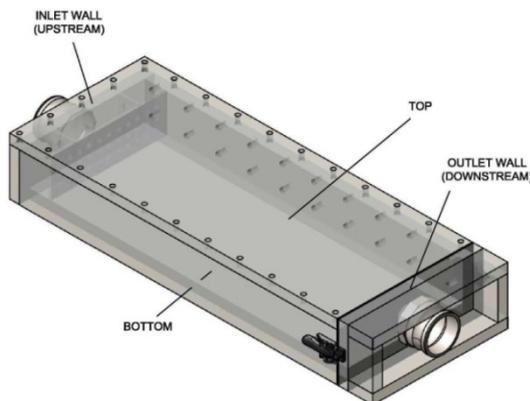
Figure 2. Schematic of small-scale flume.

The small-scale flume was designed and built as a rectangular-shaped box (Figure 2). The flume was built with 2.54-cm-thick acrylic (top, bottom, and all of its walls). The acrylic design permitted a clear view of the whole sample before, during, and after a test. Seeing through the flume would be effective not just for monitoring the initiation of piping, but also during sample preparation for visual inspection of air bubbles trapped in the system.

The top of the flume was attached along the edges of three walls by 25 bolts. The outlet wall of the box was designed to be removable and was attached to the side walls using two latches, one on each side of the

flume. The leak-proof seal was obtained by O-ring gaskets and vacuum grease in shallow grooves between the removable faces and the body of the flume. Also, a closed-cell foam rubber sheet was adhered to the outlet wall, allowing a better sealing contact.

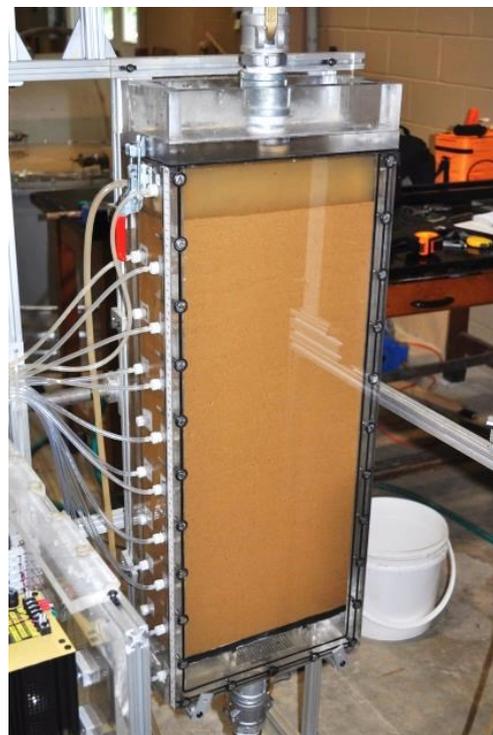
Figure 3. Small-scale flume in vertical position after sample preparation.

To ensure integral contact between the soil and acrylic, the flume was designed to be rotated 90° from an upright vertical position for filling (Figure 3) to a horizontal position for testing (Figure 4). This is similar to the tests performed by van Beek et al. (2011), whereas the flume used by Townsend et al. (1981) used a rubber bladder to apply pressure and ensure contact between the sand and the acrylic top. After testing, the flume could then be rotated an additional 90° to empty the flume by gravity. The flume was mounted to a custom frame designed for its rotation. This frame was built with aluminum t-slotted framing (80/20). The design of the frame took into consideration its capacity to sustain the weight of the flume, hoses, soil, water, and instrumentation. A rod and bearings made it possible to rotate the flume smoothly a full 180°.

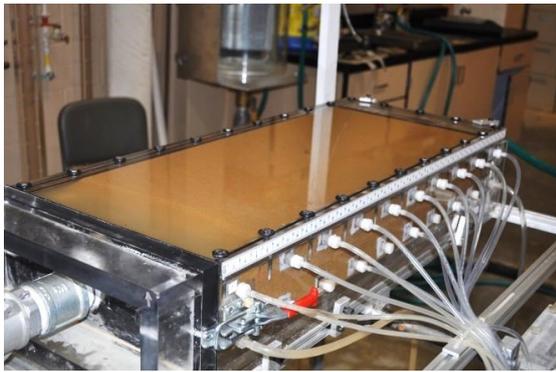
Figure 4. Small-scale flume in horizontal position for testing.

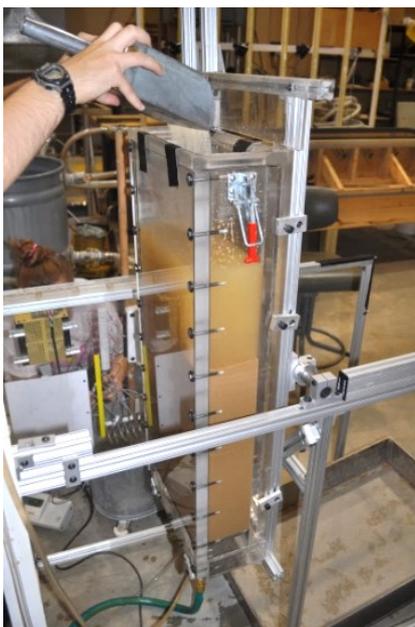
Figure 5. Pluviating sand for the preparation of test sample.

At the beginning of sample preparation, the outlet wall (downstream side of flume) was removed and the flume was rotated to the vertical position. Full saturation of samples was obtained by first filling the flume with water and pluviating (or “raining”) the air-dry sand into the flume (Figure 5). This method was used to prevent trapped air in the soil sample. Typically, about half of the flume was filled from the inlet with water before placing sand, and this was sufficient for full saturation of the sample. For the majority of the tests, a constant head water tank was used for supplying constant flow. This tank supplied water through a hose attached to the inlet wall of the flume with a 3.81-mm NPT (National Pipe Thread) stainless steel male-female coupling connector.

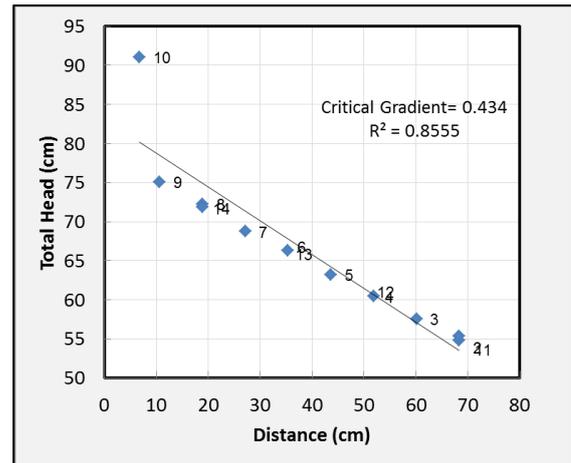
recorded, and the critical hydraulic gradient was calculated using this method. Figure 6 shows the significant head loss due to the upstream wall between pressure transducers 9 and 10. Figure 7 shows the linear fit of piezometric data points without the total head obtained from pressure transducer 10 for the calculation of a precise value of hydraulic gradient.

Figure 6. Piezometric data points showing head loss due to filter wall.

Reviewing the piezometric data showed a disproportionate head loss between the pressure transducer upstream (behind the sample and the plate) of the filter and the next transducer when compared with the head loss occurring generally in the sample. This loss increased proportionally with flow. This indicated that the filter fabric and plate geometry used was much less permeable than the material tested, as it was getting clogged with fines from the tested sands and from the water supply. This considerable head loss caused an inaccurate value for the average global gradient calculated from the upstream and downstream manometer measurements. Replacing the filter fabric periodically was not enough, therefore, the solution to this problem was to determine the hydraulic gradient by a linear fit of the hydraulic heads (converted from the measured pressure from each transducer) along the sample. The slope of this plot (Figure 6 and Figure 7) determined the hydraulic gradient across the sample. The time at piping initiation was

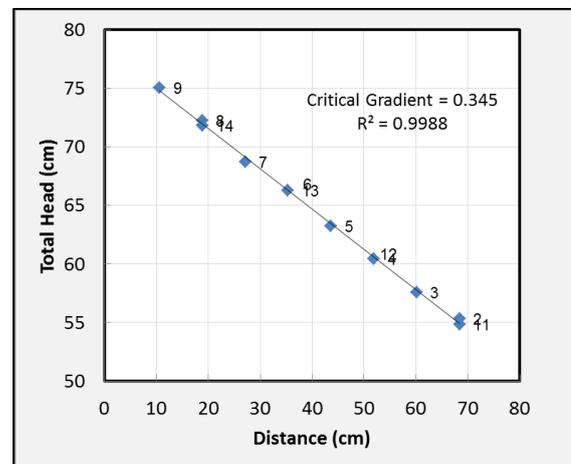
Figure 7. Piezometric data points showing linear-fit for estimating critical hydraulic gradient.

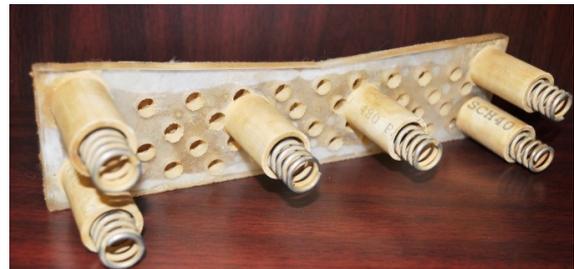
To correct this issue and ensure the pipe developed through the center of the sample in every test (or close to the center), a shallow 1:12 v-notch was cut into the half wall where the slope is formed (Figure 8). This shape caused a natural arc to form in the exit slope due to the sand coming to equilibrium at the angle of repose (Figure 9). The deepest portion of the notch was at the sample center, which forced the shortest path length to be in the center as well. When setting the flume from the vertical to the horizontal position, the newly formed exit slope of the sample was arc-shaped with the shortest flow path in the center. The shortest path distance was measured at the beginning of every test.

Figure 8. Filter wall plate with v-notch.

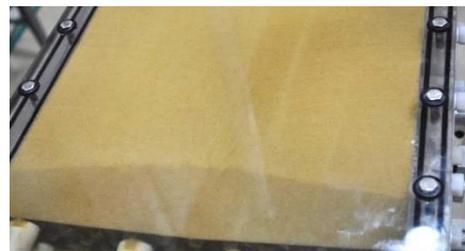
Figure 9. Arc-shaped slope formed by v-notch.
