Forensic engineering of a bored pile wall

Willem Robert de Bruin
 Geovita AS, Norway, rdb@geovita.no

1 AVLØS STATION

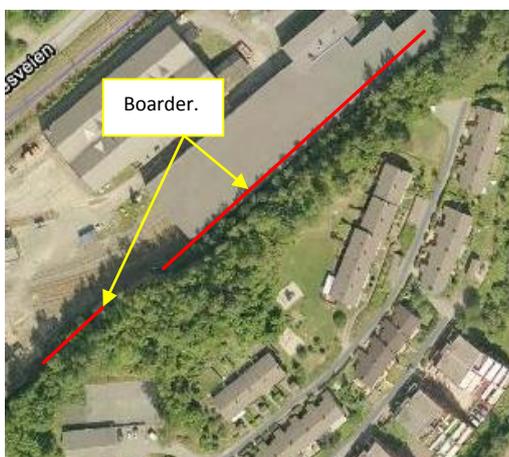
The updating of the Kolsåsbanen includes presence of maintenance and cleaning halls. The intended area however was not big enough and needed to be expanded. In order to widen the area, a large part of an existing slope had to be removed; see the red line in Figure 1 and planned excavation along the retaining wall in Figure 2.

Figure 1 Aerial view of Avløs station,

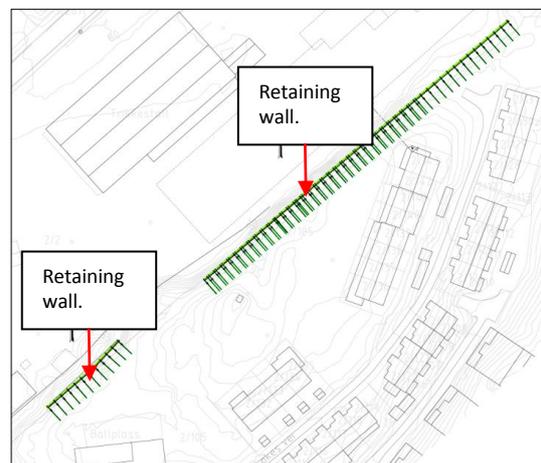
Figure 2 Overview of Avløs station.

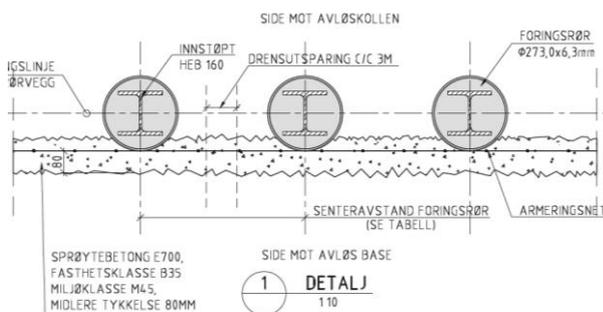
This process resulted in a bored pile wall according to the following drawings and specifications in Figure 7 and Table 1.

Figure 7 Cross section of the pile wall.

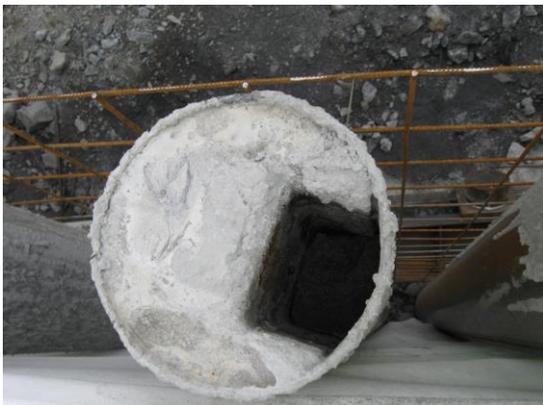
taking x-ray pictures. The result of these tests showed that up to 60% of all welding work did not meet the requested quality. On top of this, the tests were not sufficient to determine in which degree the welding itself was able to fulfil its duty. The outcome of the test was simply: “approved” or “not-approved”. Besides the fact that the welding was not approved, it showed, during a visit at the building site, that the demand for tolerance on positioning and alignment was exceeded. The image on Figure 8 shows both rotation and translation of the profile beyond acceptable and allowable tolerances. The profiles were displaced with maximum 45 degrees’ rotation in relation to the theoretical axis and in addition against the inner side of the pipe leaving no concrete cover.

Figure 8 Rotated, eccentric and a-symmetric HE-160B profile.

From the evaluation of these data, it was concluded that the quality of the structural cross-section did not meet the design requirements and measures had to be taken.

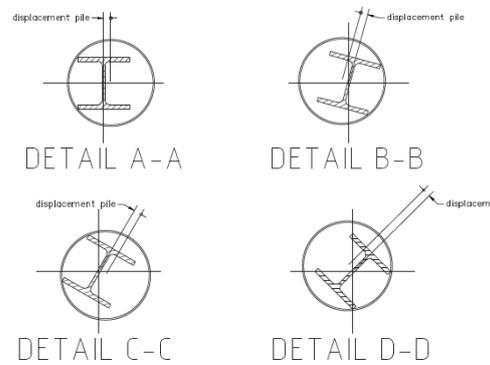
Combining these tolerances creates an image as shown in Figure 11 where the bored pile deviates from the theoretical straight line. The different sections, A – D, are sketched in the cross sections below in Figure 9. This Figure shows inconsistency in relation to the theoretical axis.

Figure 9 Rotated, eccentric and a-symmetrical profile.

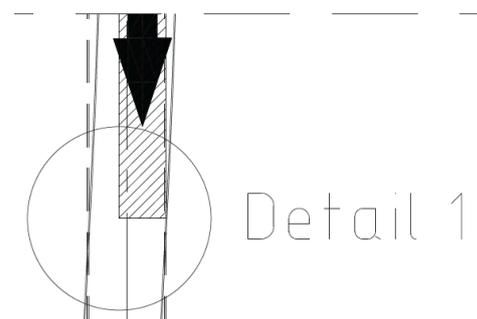
When the HE-B profile is installed, the pile will make contact at one side of the pipe, see Figure 10.

Figure 10 Collision of the profile with the inner side of the pipe.

With this contact the HE-B profile will follow the direction or alignment of the pipe locally which has different directions in cross section A, B, C and D. As a consequence, the HE-B profile will turn and finally rotate.

This process is a direct result of the profiles own weight and therefore the rotational movement goes with great forces which cannot be adjusted during installing neither changed after the profile has reached its final depth.

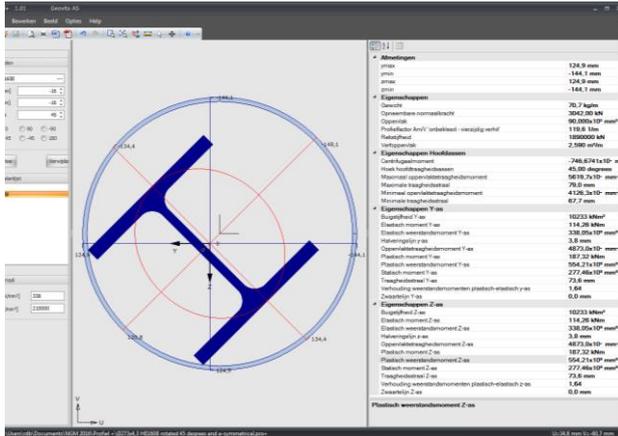
See Figure 12 for the calculation of the displaced and rotated profile, with corresponding deviation in relation to the obtained capacity. Table 2 shows an overview.

Figure 12 Calculation of the rotated, eccentric and a-symmetric composite profile.

The capacity of the piles was reduced with 19% in elastic state and approximately 15% for the plastic state. The proper way to calculate the moment of inertia for hybrid profiles with translational and rotational motion is by using Steiner's theorem.

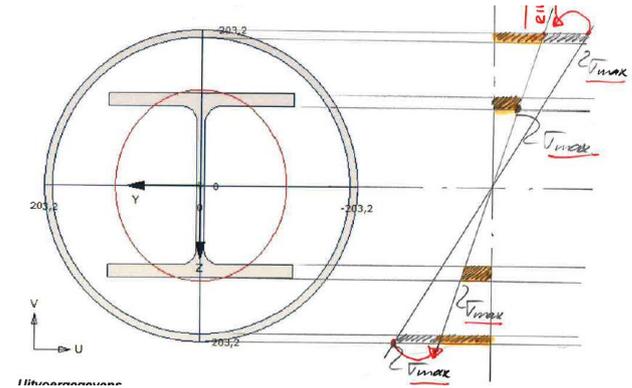
It is not allowed to simply add the moment capacity of the tubular pipe and that of the beam, $M_{pipe} + M_{HEB160} = (78,72 + 105) * \text{centre distance} (1/0,6) = 306,4 \text{ (kNm)}$.

This will give considerable more capacity in relation to the calculated. This is due to the fact that both profiles do not have the same neutral line to be followed with calculating the maximum moment capacity, see Figure 13.

Figure 13 Capacity overview of the rotated, eccentric and a-symmetric composite pile profile.

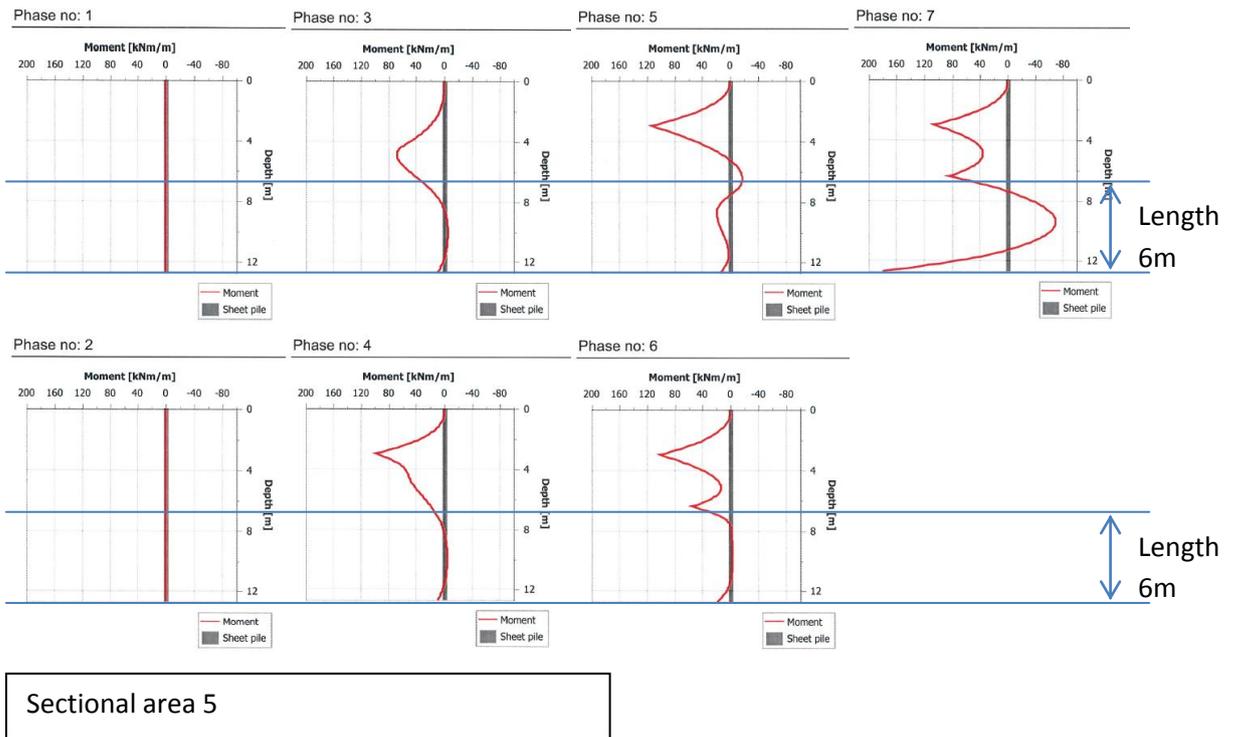
The challenge with the welding was charted by checking welding protocols on welding positions along the tubular pipe. The charted overview visualized that the first elements which were bored, were 6 meters long, containing no welding.

This led to the conclusion that 100% of the designed capacity was still in place over the first 6 meters, of course with deduction of capacity due to corrosion. Along the remaining part of the wall the capacity was reduced to the sum of the rotated profile and the surrounding concrete. Figure 14 shows that calculated data from Figure 12 and Table 2 still provides enough capacity for the lower 6 meters.

Figure 14 Chartered moment capacities versus placement of welding.

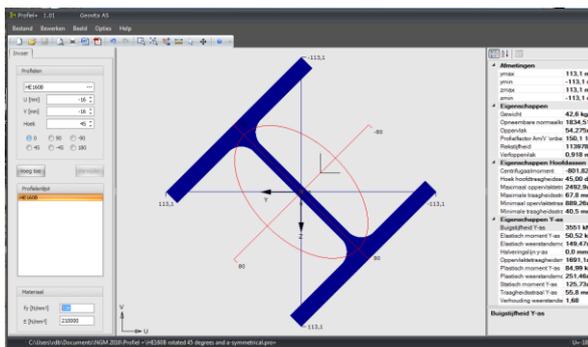
The remaining length was checked by heavily reduced moments of a profile without contribution of the tubular pipe, in addition to capacity calculated as given in the overview of Figure 15 and Table 3. Elastic capacity was reduced with 64% and plastic with 40%.

Figure 15 Calculation of the rotated, eccentric and a-symmetrical non-composite profile.

As shown in Table 3 the capacity of these piles was reduced with 64% in elastic state and approximately 40% for the plastic state in relation to the original capacity.

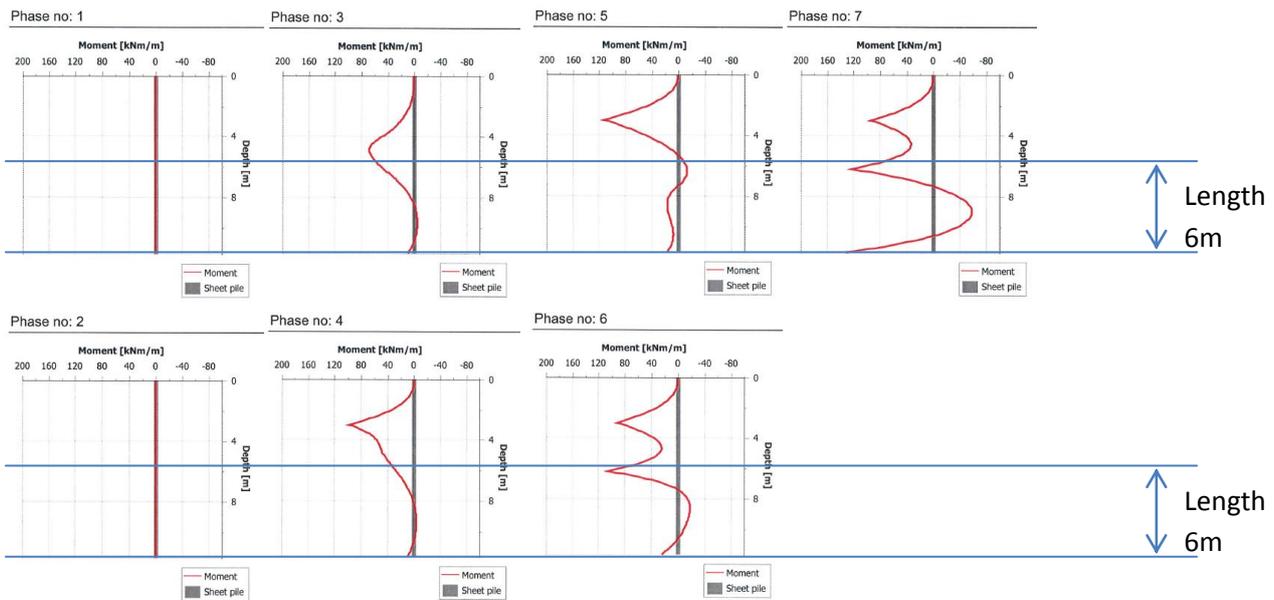
Figure 16 Chartered moment capacities versus placement of welding.

Controlling capacity after installing showed that in future cases the location of the welding should be done in front. Locations of moment should be linked with necessary welding and described on as-built drawings, preventing welding in the vicinity or directly near locations with large moments in the pile wall. The same is also important for the girders along the pile wall, here it's also possible to end up with welding in the vicinity of or influence zone of large moments. The reduced shear force capacity did not create a problem since this was sufficient from the HE-B profile.

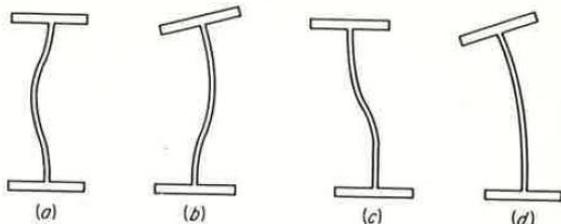
- Local buckling
- Shear buckling
- Axial – torsional buckling
- Lateral – torsional buckling
- Web crippling and web yielding

Figure 17 a) Web yielding... d) Web crippling

The presence of the concrete poured scale surrounding the HE-B profile functioned as plate girder, web stiffener and transverse stiffener which showed to be sufficient after control. The soil anchors with girders functioned as buckling strut, reducing the buckling length considerably.

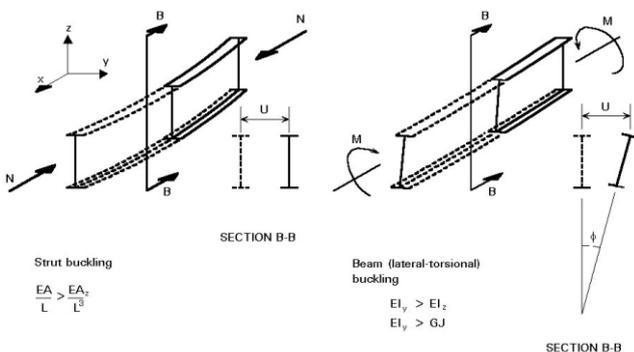
Figure 18 Strut buckling and lateral torsional buckling
