# The traffic junction Lindholmsmotet in Gothenburg: An example of creative geotechnical engineering in the construction phase

T. Edstam

A. Kullingsjö

## ABSTRACT

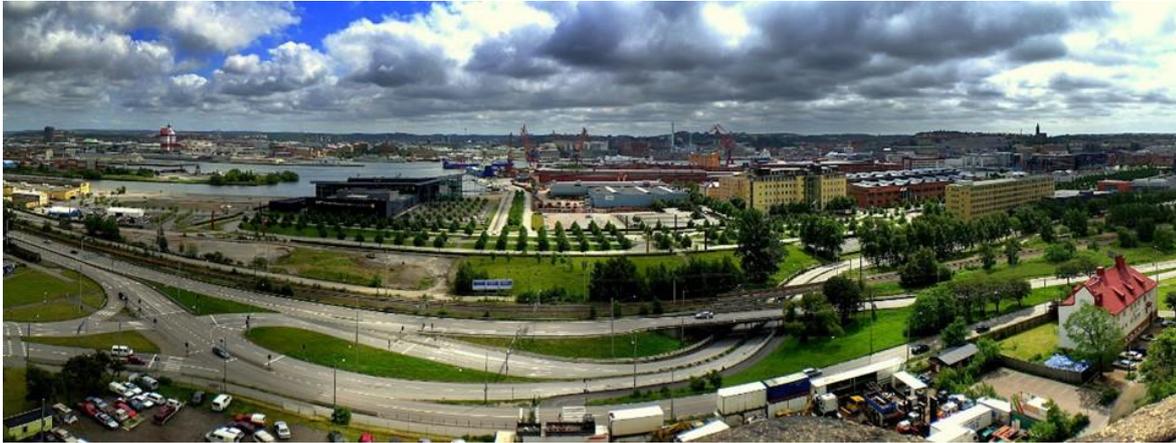
*Figure 1. The original traffic junction.*

Due to the urban location of the junction there were several geometrical constraints to handle, such as an adjacent railway (of major importance for the Port of Gothenburg) and the existing traffic junction which both should be fully operational during the construction phase, cf. Figures 1-3.

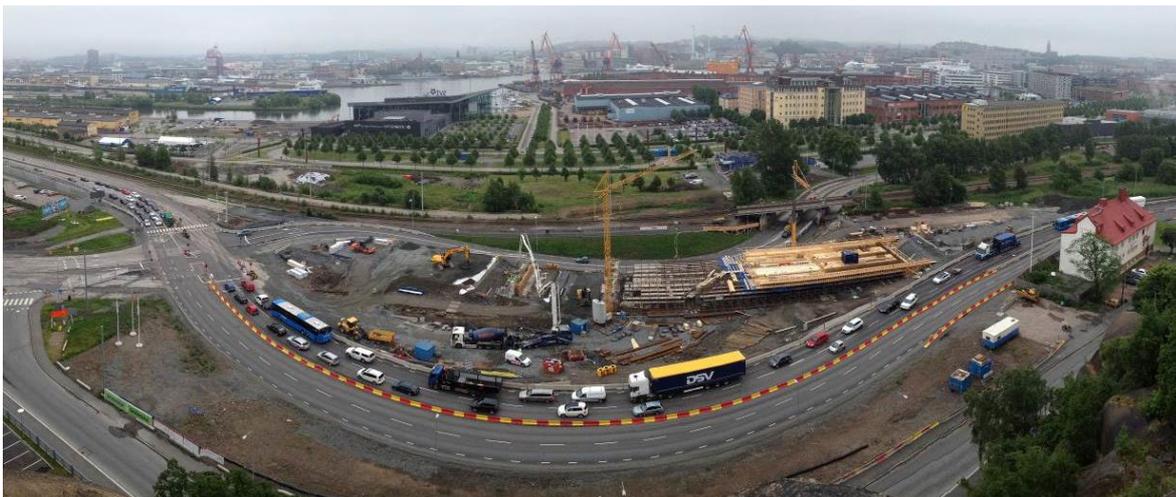
*Figure 2. The new traffic junction during construction.*

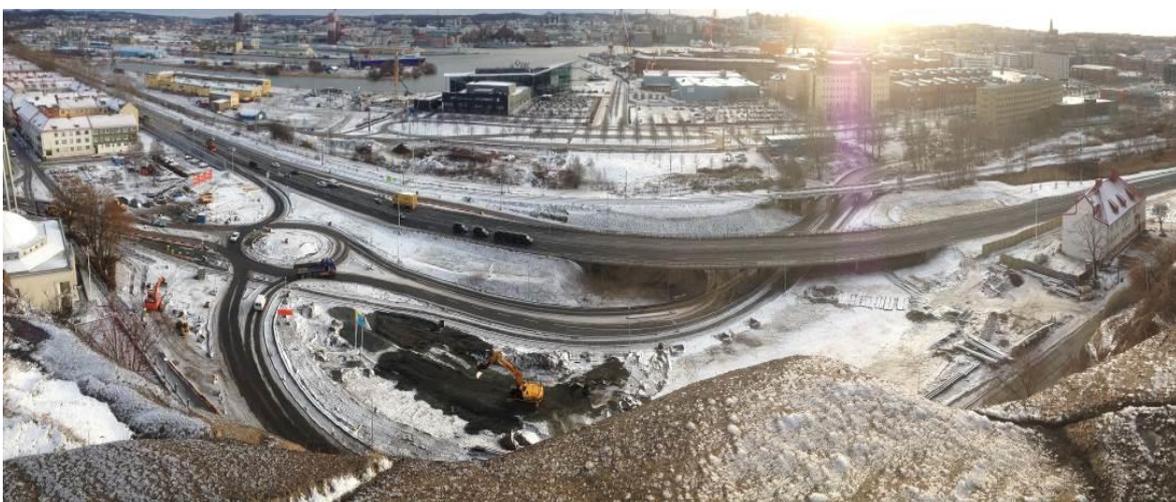
*Figure 3. The new traffic junction just after completion.*

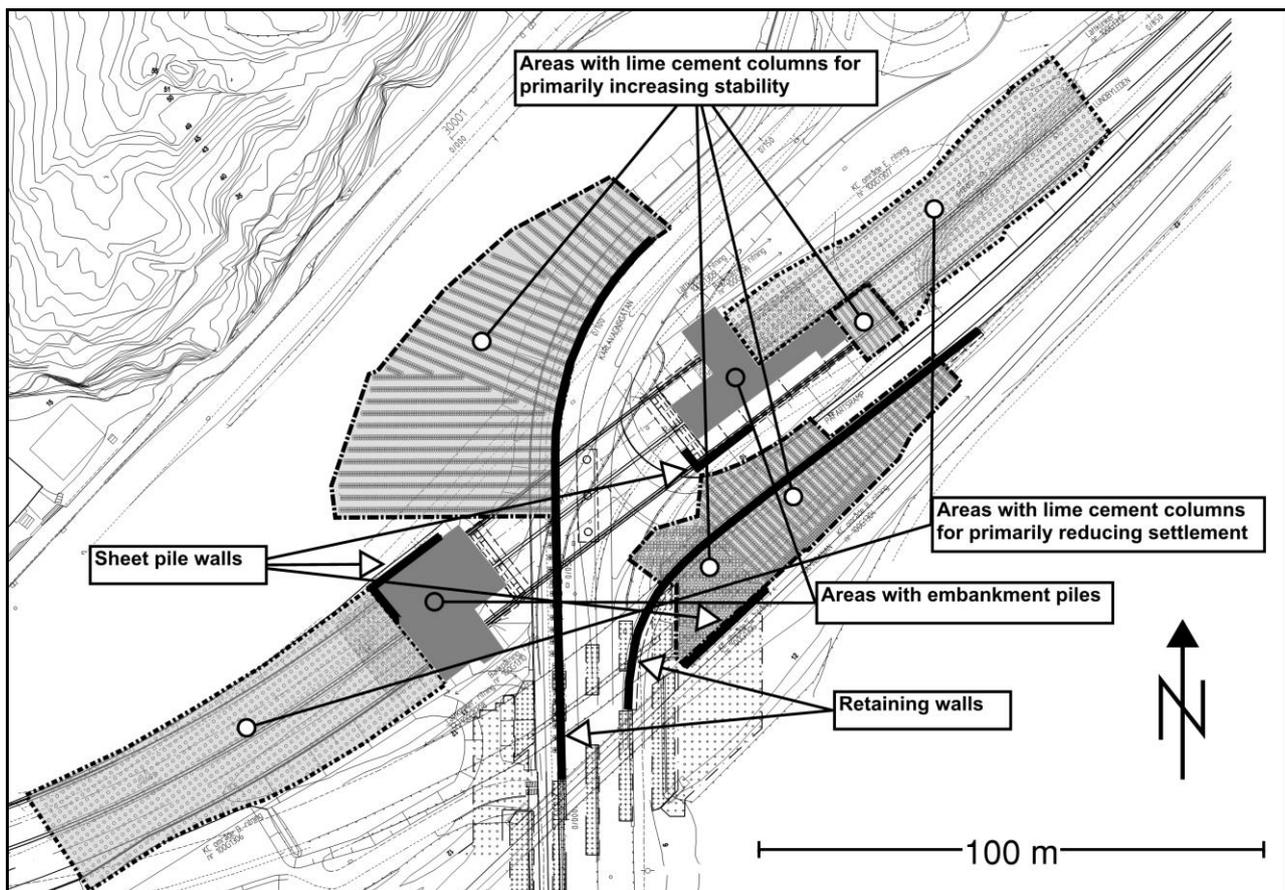
Figure 4. Plan drawing showing the major geotechnical measures (lime cement columns, embankment piles, retaining walls and sheet pile walls) that were required according to the Contract Documents.

The Contract Documents also included drawings showing the prescribed geotechnical measures that was required in order to fulfil the stability and/or settlement requirements after completion of the new junction. Most of the geotechnical measures consisted of lime cement columns (a total of about 150,000 linear meters), cf. Figure 4. Furthermore, two retaining walls, three sheet pile walls and two regions with embankment piling were prescribed in-depth, even though the contractor should perform the detailed design of these.

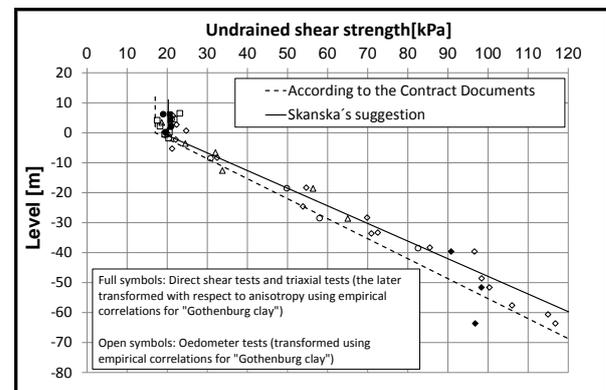
Figure 5. Strength profile of the clay according to the Contract Documents and according to Skanska.

The prescribed undrained shear strength (characteristic value) varied somewhat within the site, but it was in the order of 15-17 kPa

in the upper part of the clay layer, while further down increasing by 1.3-1.5 kPa/m with depth. The prescribed preconsolidation pressure (characteristic value) was typically 4.5-5 times larger than the undrained shear strength.

Therefore, by combining the site-specific results with a substantial in-house experience of the behavior of Gothenburg clay a new strength profile was suggested, cf. Figure 5.

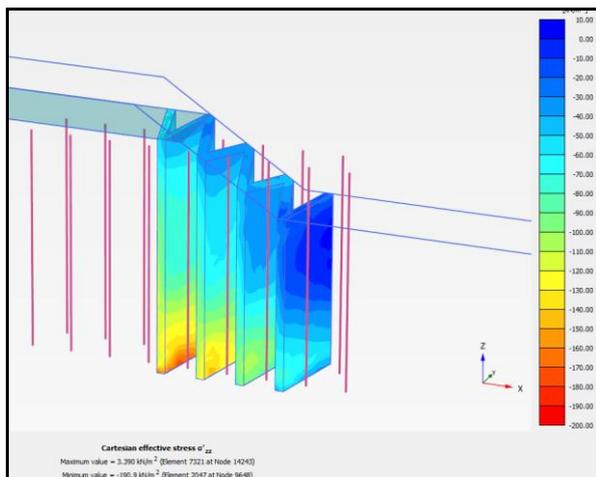
Figure 6. 3D finite element analysis for studying the stabilising effect of timber piles circumscribed by grids of lime cement columns.

The geotechnical engineers at Skanska also realized that instead of removing some of the existing timber piles close to the railway (as stipulated in the Contract Documents since the piles were in geometrical conflict with the prescribed lime cement columns) their stabilizing effect could be accounted for. In order to convince the Client on how to quantify this stabilizing effect some 3D finite element analyses were performed, cf. Figure 6, in parallel with more conventional stability analyses. A combination of such analyses and a careful documentation of the actual location of the existing piles made it possible to design a tailor-made installation pattern, in which grids of lime cement columns circumscribed each individual pile.

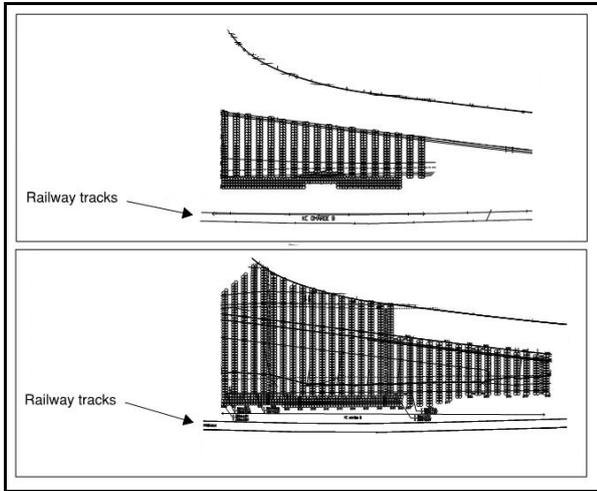
Figure 7. Lime cement columns next to the railway. Lower figure: According to the Contract Documents; Upper figure: After Skanska's redesign.

A comprehensive monitoring program was implemented in order to assure that the construction works did not jeopardize the stability conditions or the functionality of the surrounding railways and roads. Especially the displacements of the railway were thoroughly monitored using both automatized inclinometers, installed to a depth of about 20 m as close to the tracks as possible, and manual measurements of the railway tracks. During the installation of the lime cement columns just north of the railway the tracks were expected to displace southwards and upwards, potentially making the tracks untrafficable. The expected final displacement of the tracks and in the underlying ground were assessed in the early stage of the lime cement column installation using a method originally suggested by Sagasetta (1986) and successfully applied for pile installation in Gothenburg clay (Edstam & Kullingsjö, 2010). The assessed displacement of the tracks were larger than considered acceptable according to the Contract Documents, even though the amount of lime cement columns in the area next to the railway had been considerably reduced compared to the original requirements, cf. Figure 7. Therefore, during the installation of the columns a very close

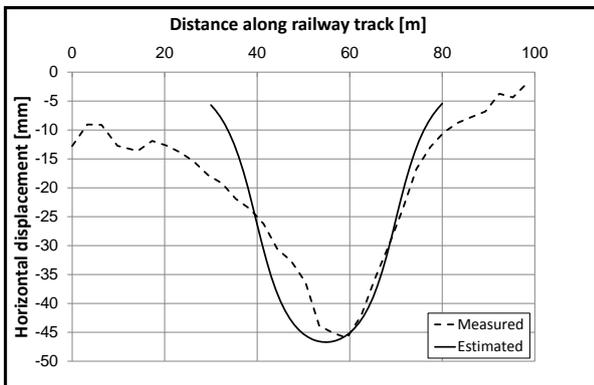
Figure 8. Assessed and measured horizontal displacement of the railway tracks.

As may be seen in Figures 8 and 9 there is a rather good agreement between the assessed and measured horizontal displacements, both at the ground surface (the tracks) and with depth. Even though the measured displacement exceeded the allowable levels the train traffic could proceed without any interruption. Only minor adjustments of the tracks were required and this could be done during time slots where no trains were passing the construction site.

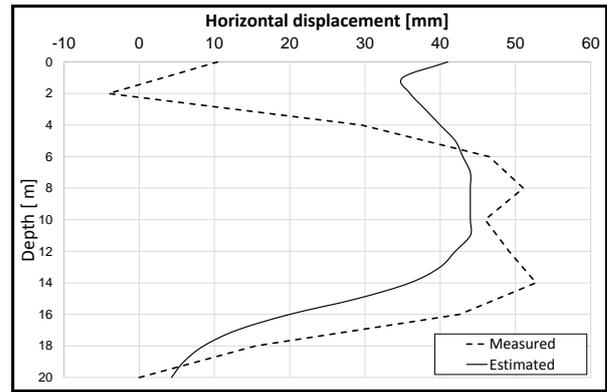
Figure 9. Assessed and measured horizontal displacement in the ground next to the railway.

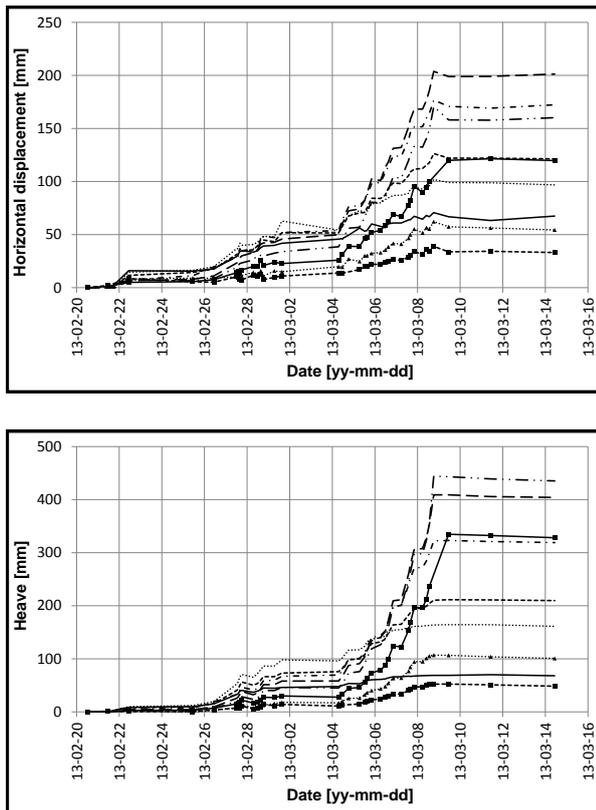
Figure 10. Measured horizontal and vertical displacement at various locations along a road located at the toe of an existing slope.

The lime cement columns were partly installed just behind the crest of an existing slope with a public road next to the toe of the slope. Therefore, Skanska recommended that the stipulated monitoring program should be extended in order to keep track of the displacement of that public road. The displacements were rather modest in the early stage of the column installation. On the contrary, in the later stage the displacement increased very rapidly resulting in considerable concern about the stability conditions. Therefore, it was decided to reduce the installation rate and extend the monitoring program. During the subsequent installation works it was noted that as soon as the installation was interrupted no further ground displacements developed, indicating that the clay was very ductile. Eventually, the road was displaced up to 0,2 m horizontally and 0,45 m vertically, cf. Figure 10. During the subsequent excavations the railway tracks were displaced in the opposite direction to that occurring during the column installation. In the final stage, the tracks had returned to almost the same position as before the construction works commenced.
