Geotechnical Engineering for a new container terminal in Lomé, Togo, West Africa

ABSTRACT

The article will focus on a comparison of the assessment in the design phase of the conditions for foundation of the container berth with actual observations during and after construction.

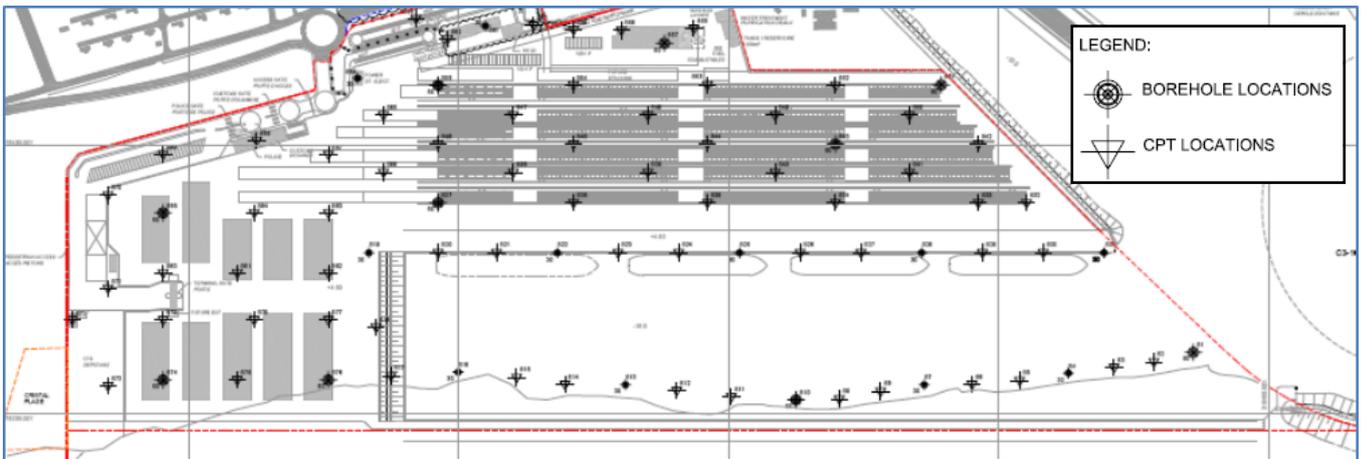
Figure 4 Plan of pre-tender soil investigations 2011.

Before tendering a more extensive investigation was carried out, see Figure 4, including:

- 21 boreholes to depth ranging from 17 m to 51 m.
- 85 CPTU (Cone Penetrations Tests with pore pressure measurements) to depths ranging from 13m to 48 m.
- Laboratory testing for classification and soil strength parameters.

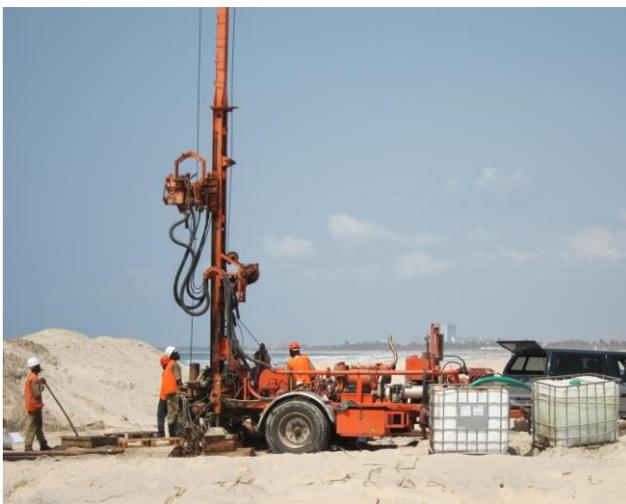
Figure 5 Geotechnical borehole with an interim dam to the left for protection of sea waves. March 2011.

Figure 5 and Figure 6 show the drilling and the CPT rigs that were mobilized for the investigations in 2011. CPT-equipment and counterweight were installed on a sledge towed by a Caterpillar. This vehicle proved convenient for access all over the site.

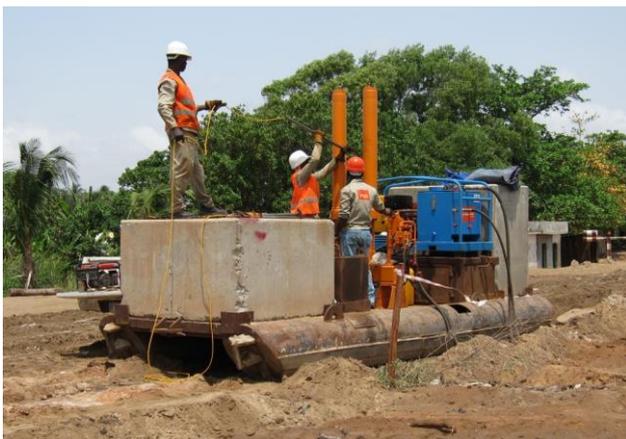
Figure 6 Cone Penetration Test (CPTU) equipment (20 ton capacity). March 2011

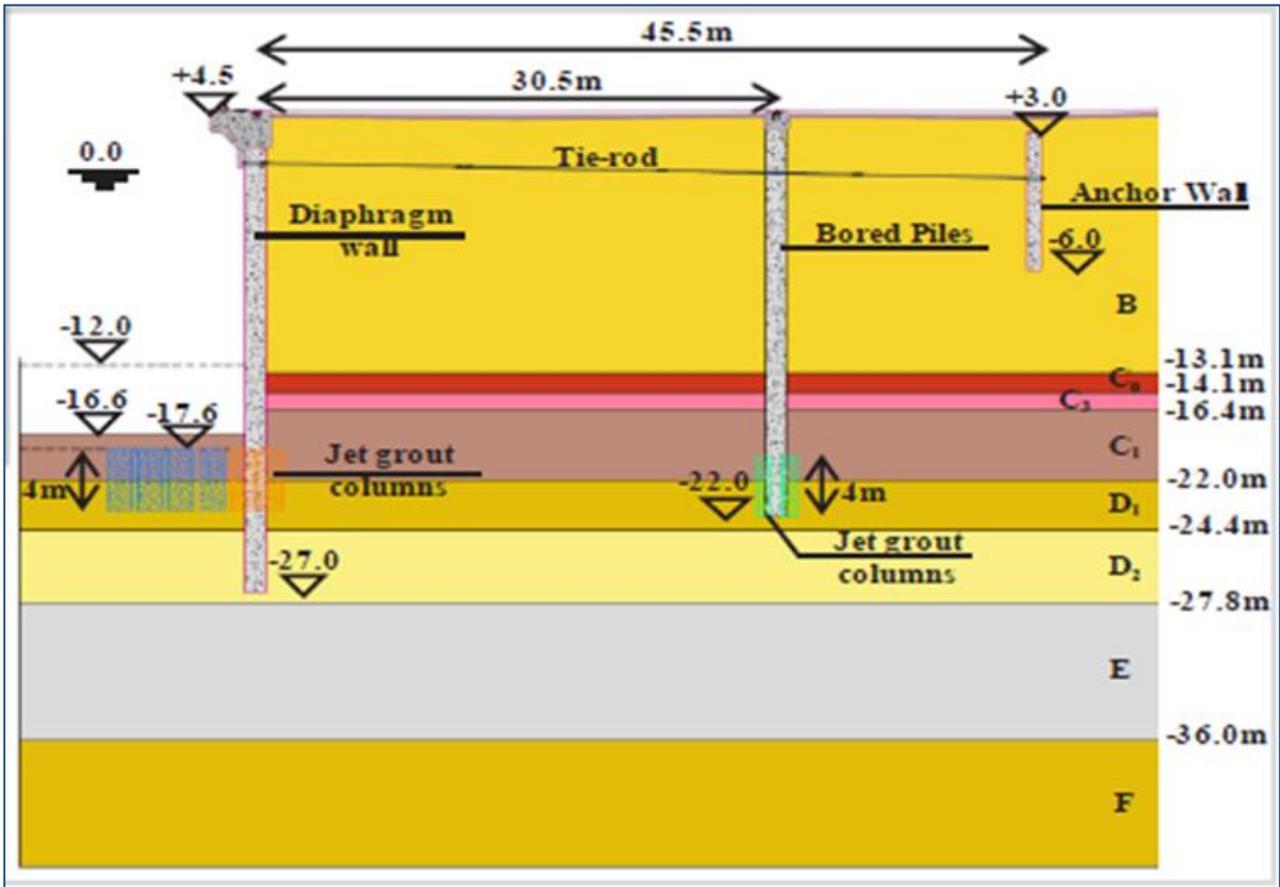
Figure 7 Soil layers and configuration of quay structure.

A typical cross section in the main quay wall is shown in Figure 7 which also includes references to the soil layers A-F. Little variation across the site was detected.

The quay structure consists of a 1.2m thick reinforced concrete wall, cast in-situ as a diaphragm wall as shown in Figure 7. The

The dimensions of the quay structure are constant along the entire length of the main quay. Minor variations in the soil profile are accounted for by local strengthening of critical sections with jet-grouting columns – as shown in Figure 7.

The work specification included deep vibro-compaction (see Figure 16) of all naturally deposited sand (layer B in Figure 7) to reduce settlements in the future stacking areas.

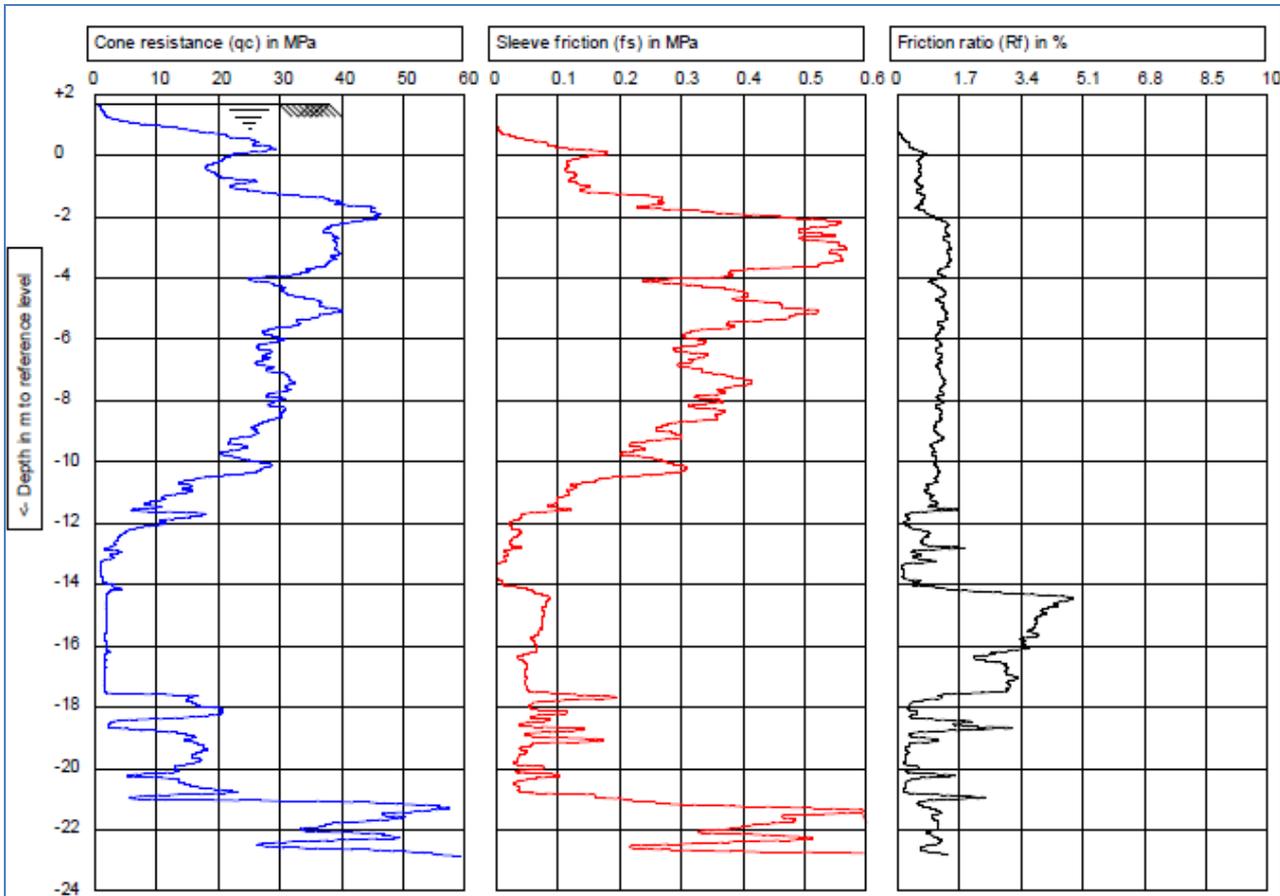
Figure 8 Results from Cone Penetration No. S24 indicating a clay layer at level -14 to -18.

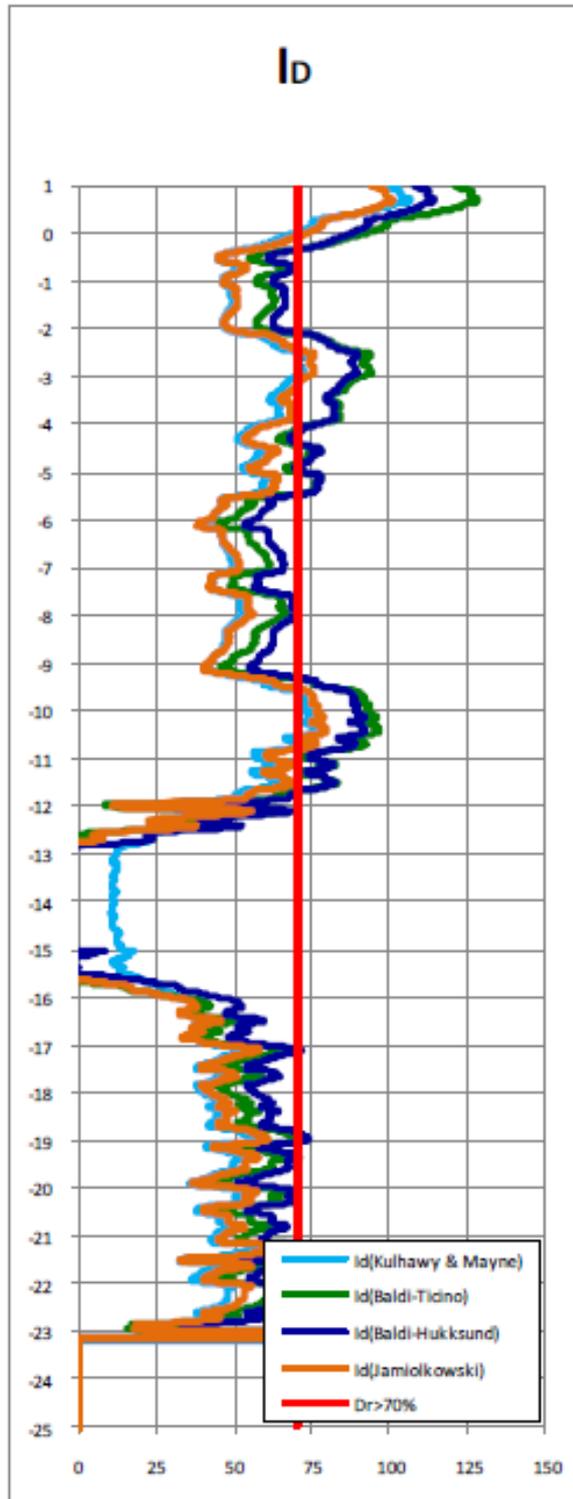
Figure 9 Assessment of relative density I_D , based on CPT-tests.

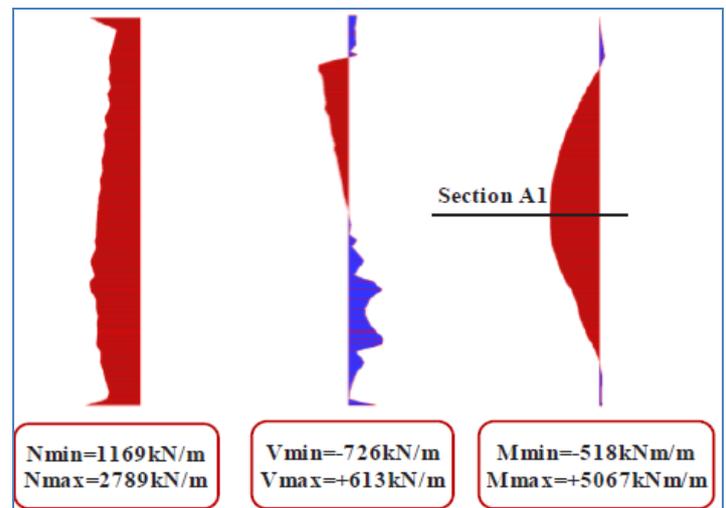
Figure 10 Example of calculated forces in quay wall.

Typical result schemes are shown in Figures 10 and 11.

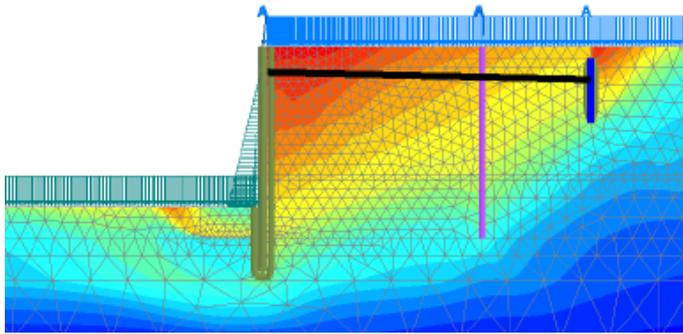
Figure 11 Example of global stability analysis (Plaxis 2D).

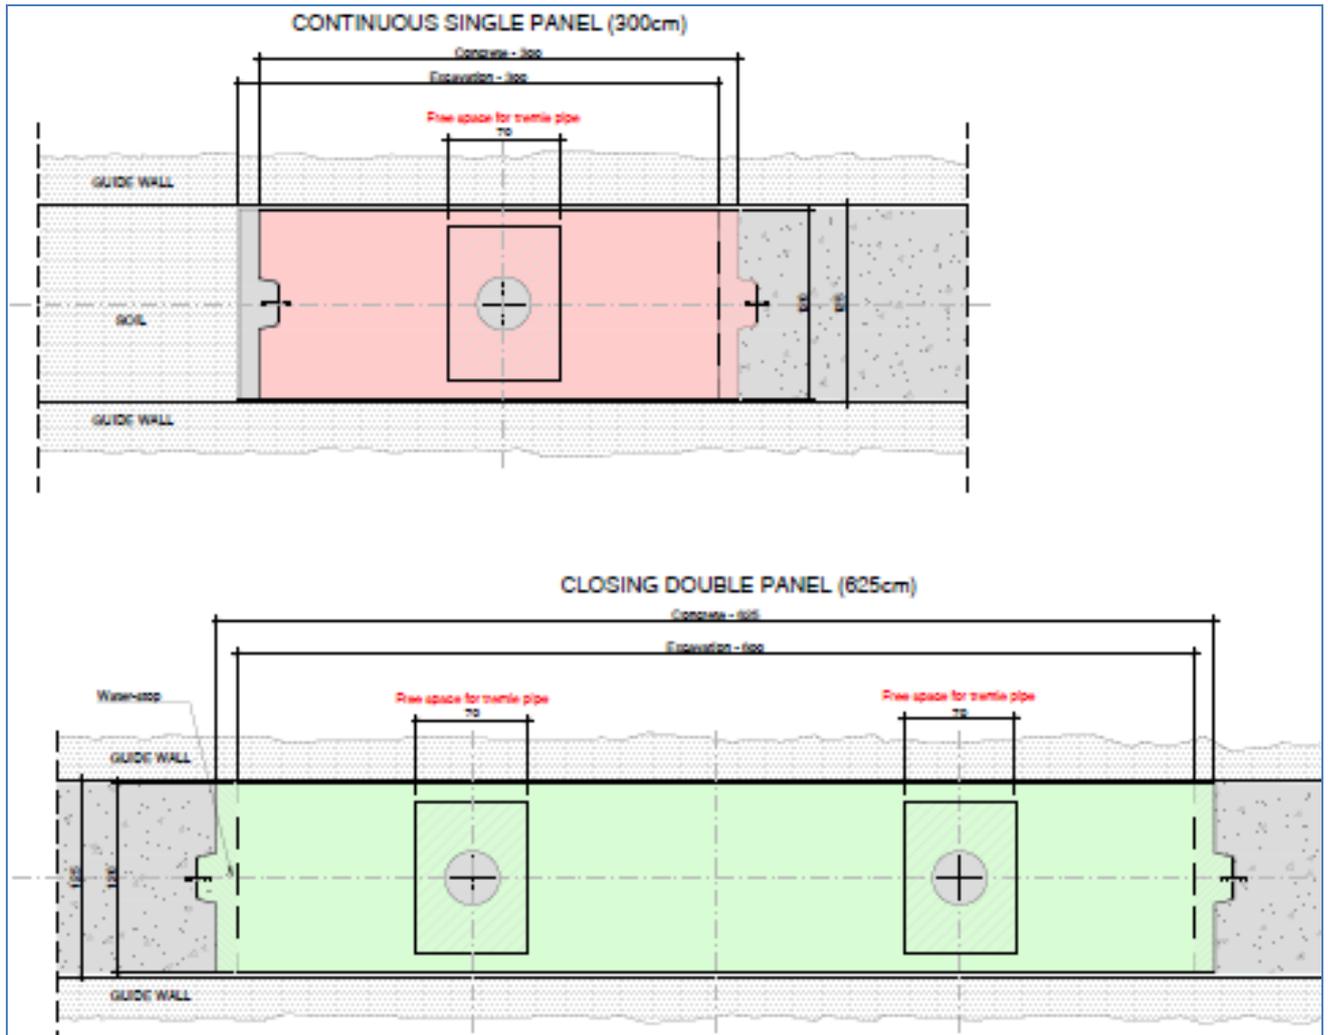
Figure 12 Typical panel sections in diaphragm wall with watertight joints between panels.

The wall was constructed in sections of 3 or 6 m width. Construction included excavation, stabilization of the trench with a bentonite slurry, installation of reinforcement cage and concreting.

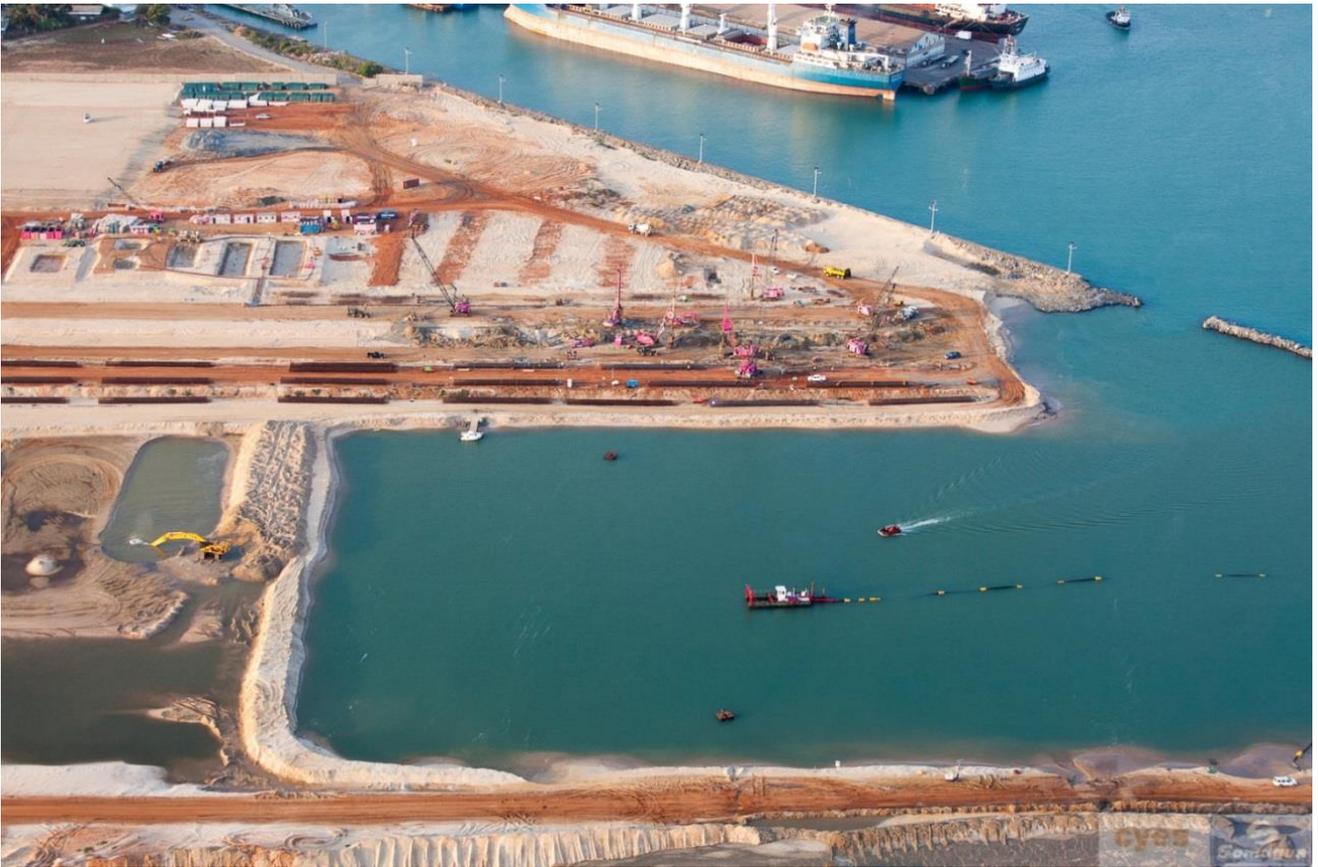
Figure 13 East part of the new basin with reinforcement cages ready to be installed. November 2013.

Figure 13 to Figure 15 show some views related to the construction of the quay wall.

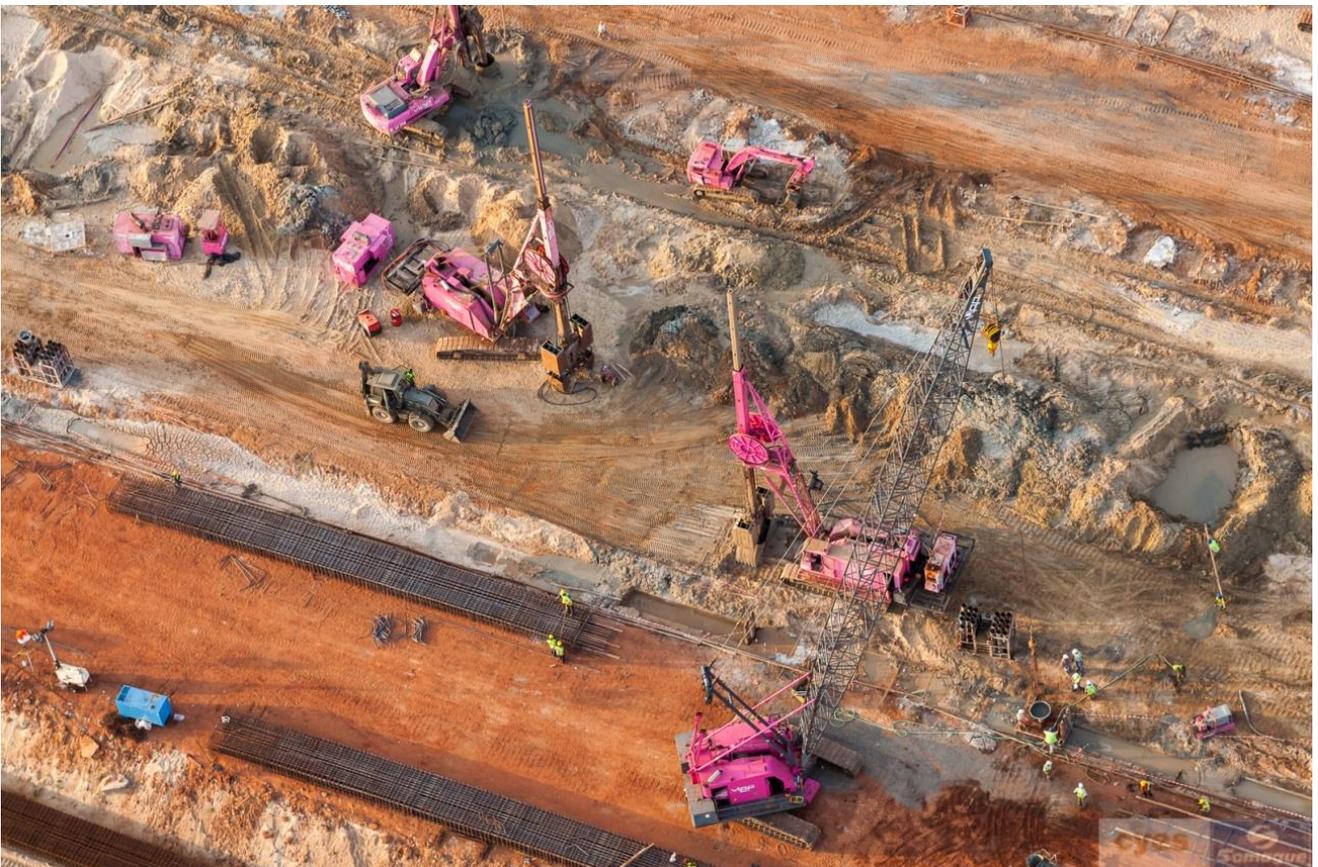
Figure 14 Machinery for the diaphragm wall and reinforcement cages to be installed. November 2013.

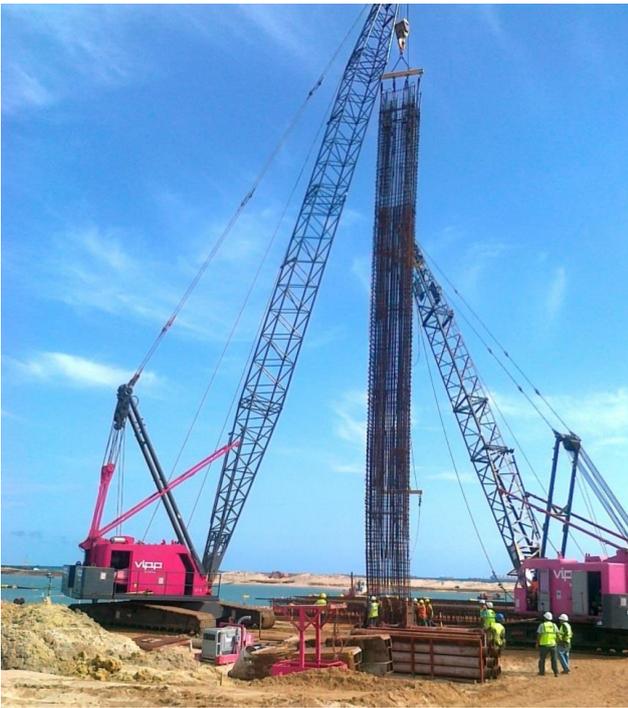
Figure 15 The reinforcement cages (app. 30 m long) for the diaphragm wall were lowered into the trench. November 2013.

All bentonite was recirculated in the works after thorough treatment and testing of properties. Raising the 30 m long, prefabricated reinforcement cages from horizontal to vertical proved difficult and required application of some skill from the contractor's side.

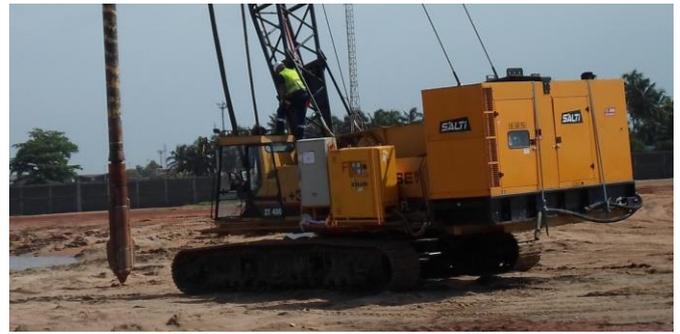
Figure 16 Vibrator for the deep compaction. May 2013

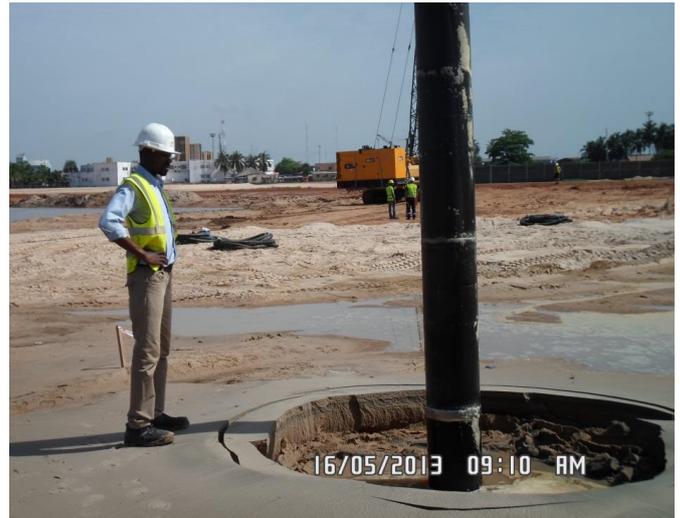
Figure 17 Local recess of the ground surface during the deep compaction. May 2013.

The contractor's compaction methodology and procedures were initially refined and optimized in a few test sections based on CPT-testing before and after compaction. From the tests it became clear that in large parts of the construction area the effect of deep compaction would be rather limited. Some densification was achieved in the lower part of the sand layer. But penetration of the upper zone resulted in apparent loosening of naturally dense sand as indicatively shown in Figure 17.

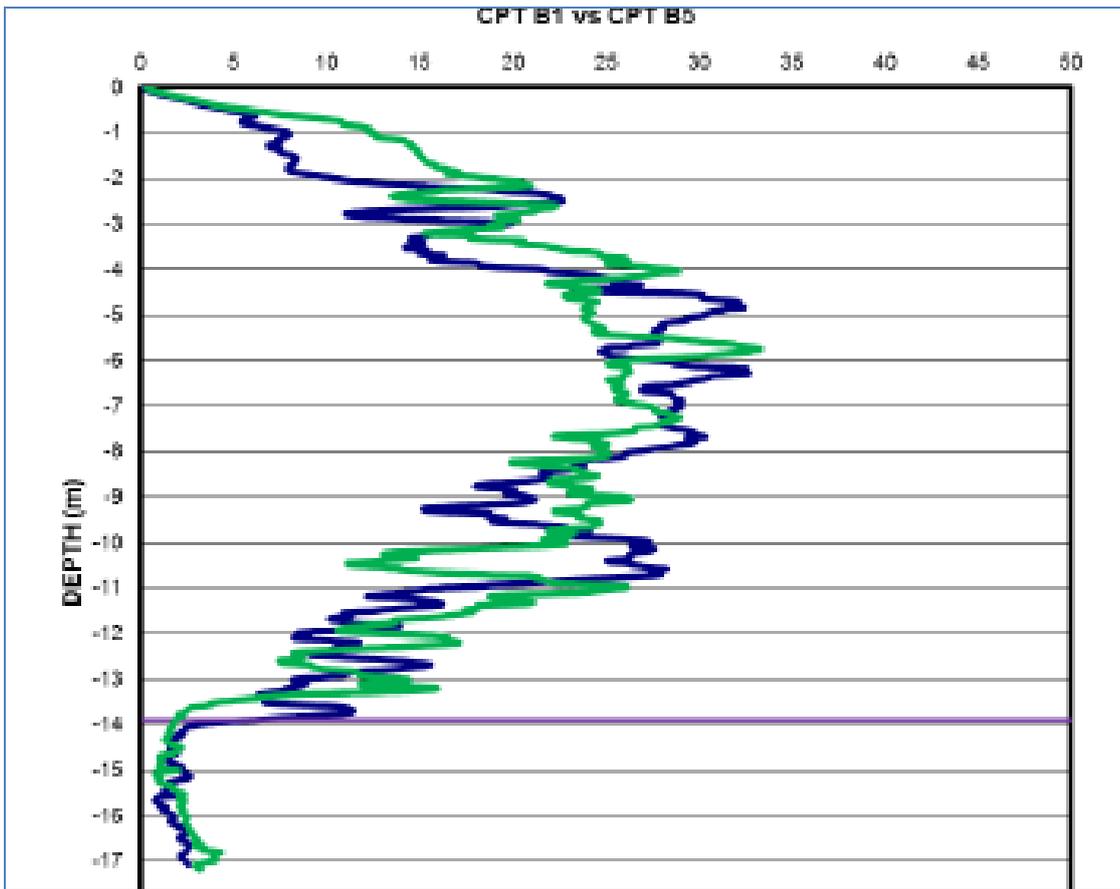
Figure 18 CPT-testing results before and after compaction (Blue color: Before compaction. Green color: After compaction).

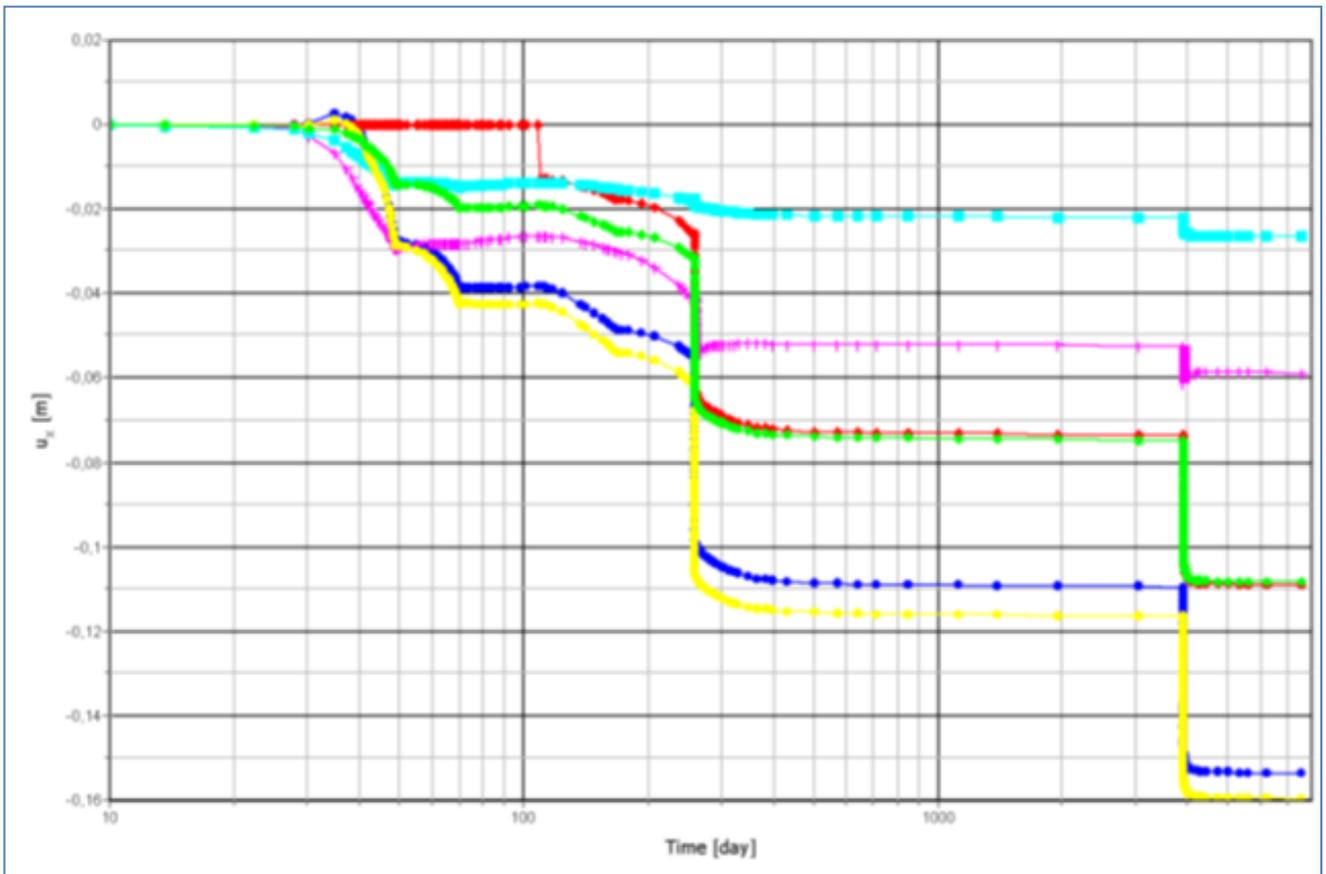
Figure 19 Calculated horizontal displacements with time for different control points.

Displacements, horizontal and vertical, were calculated for different control points in the quay structure (top of quay wall, crane beams, anchor wall etc.) and for different stages of construction and operation. Typical results from the analysis are shown in Figure 19 where each color represents a defined control point.

A maximum horizontal displacement of 61mm was calculated, meeting the requirement ($< H/300 \approx 100\text{mm}$). The relative displacements of crane beams were also calculated to be manageable with regard to the selected rail system.

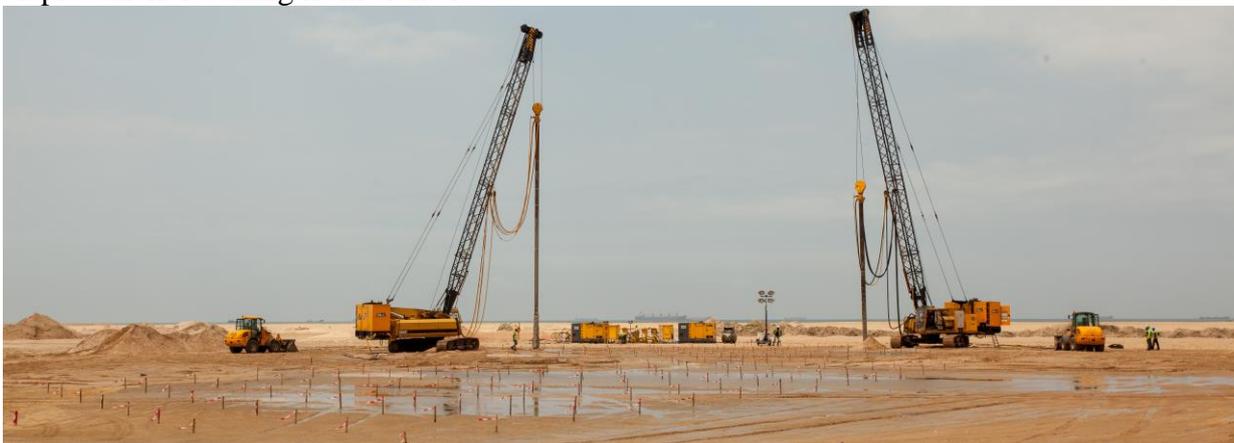
Figure 20 Machinery for deep vibration compaction. Distance between the points is app. 3 m. July 2013.
