Freezing techniques made a new tunnel possible

In the centre of Copenhagen, at Nørreport Station, a new tunnel with 2 escalators has been constructed. The area around Nørreport Station is one of the busiest places in Copenhagen and the construction site was in the middle of it. The construction site was extremely tight, 10x40 m. The execution phase was separated in two main construction stages, a pit and a tunnel. This paper focuses mainly on the tunnel part, which was made underneath an existing bus area and a train tunnel, close to neighbouring buildings and just above two existing metro tunnels. The tunnel part was constructed by using the New Austrian Tunneling Method and freezing techniques. Züblin A/S was commissioned to plan, design and construct the new tunnel Ny Metrotrappe.

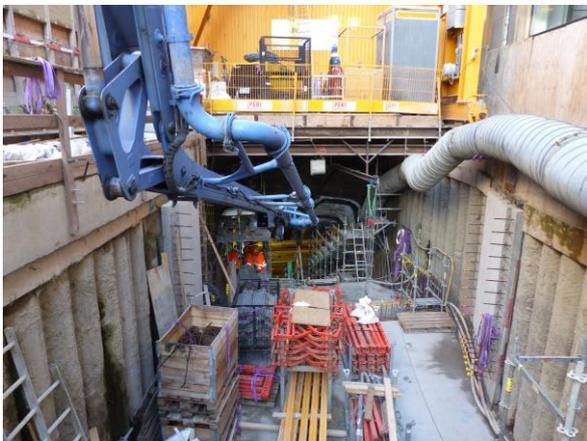
Figure 2: Construction pit in a late stage

Frederiksborggade no. 14 (see Figure 2). The width of the tunnel was about 4-5m and the height is about 2.75m. The length of the tunnel is approximately 50m in total.

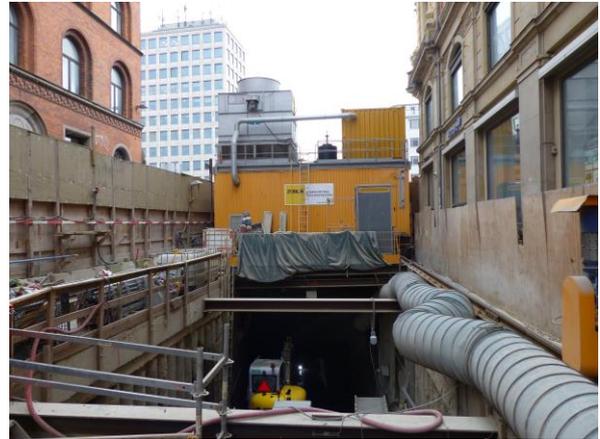
and static loads from soil, water, neighbouring buildings and surface loads. Furthermore, piles were embedded in clay till, resulting in a groundwater cut-off and it was expected that no groundwater would leak into the pits during construction. The shallow pit is shown in figure 5.

Figure 5: Shallow Pit with freezing system on top

However, jet grouting was planned to be performed to form a deep grouted sealing blanket but it did not work out and instead an ice block was made. After repeated adjustments of the jetgrouting setup it was not possible to get a watertight blanket and furthermore the strength of the blanket was not fulfilled according to the design. No groundwater lowering outside the pits was carried out because of considerations for the surroundings. The pit was secured against uplift of the ground and water ingress. It was intended to use the freezing method for the deep pits after the installation of the secant pile to form a watertight plug close to the level of the pile toe (see figure 6). Freezing pipes were installed from ground surface and only inside the deep pits and the middle pit. The excavation level of the shallow pit was higher than groundwater level in the middle pit.

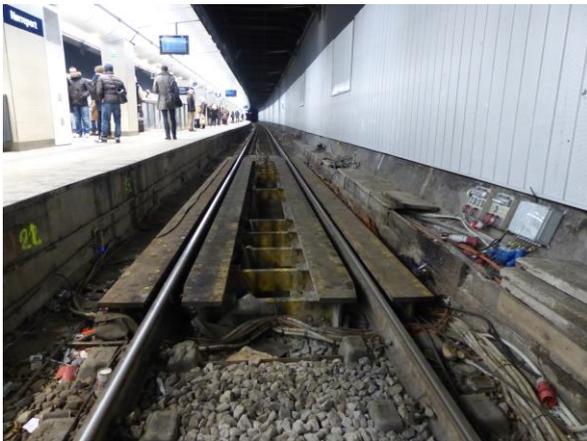
Figure 7: Temporary bridge on track no. 1

Track no. 1 (see figure 3) in the Boulevard tunnel was temporarily supported before excavation below the track could be commenced. It was intended to install a “rail bridge” inside the Boulevard tunnel and the span of the bridge was the same as the width of the temporary freezing profile. The bridge prevented any trainloads from track no. 1 on the Boulevard bottom slab just above the working area (see figure 7 & 8). The concentrated load was precisely above the centre line of the freezing profile. The design of the track support was done by others.

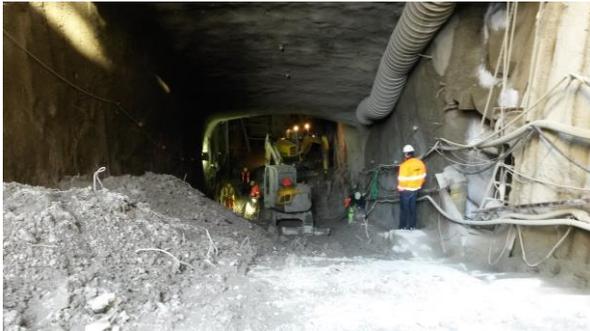
Figure 13: The slope of the new tunnel

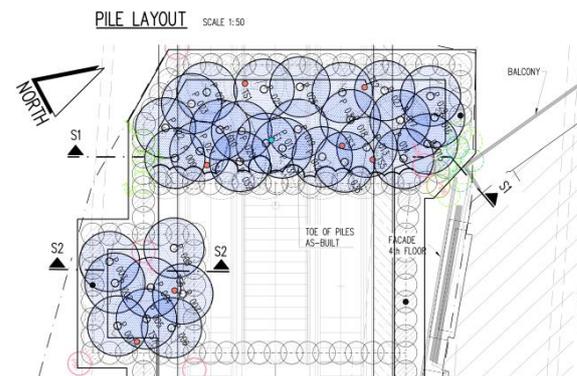
Figure 16 shows the layout of the freezing pipes and the freezing slab of the deep pit in its vertical expansion.

Figure 16: Layout of vertical freezing pipes in deep pits

In the deep pits vertical freezing was carried out with in situ freezing in the bottom. The freezing slab lies mostly between -6.1m DVR and -7.6m DVR (see Figures 6 & 16). The top of the metro tunnel is at around -8.2m DVR. The normal soil temperature was

assumed to be +12°C. Inside the metro tunnel the temperature is surely higher because of the operating trains. The average temperature inside the freezing slab was -10°C. Based on the short distance between freezing slab and metro tunnel there was interference between them. To ensure the low temperatures inside the freezing slab, the freezing pipe distances above the metro tunnels were decreased.

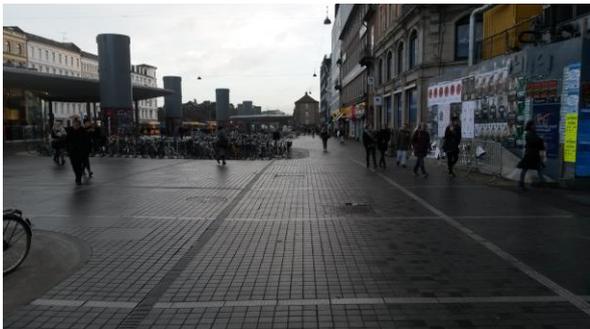
- In the paved area on top of the Boulevard tunnel the maximum vertical deformation was almost in line with expectations, but the main part disappeared when the freezing system was shut down (see figure 20)
- The 100 years old Boulevard tunnel had a vertical deformation, which was more than the limit value – this was difficult to

Figure 20: Pedestrian street just above the tunnel

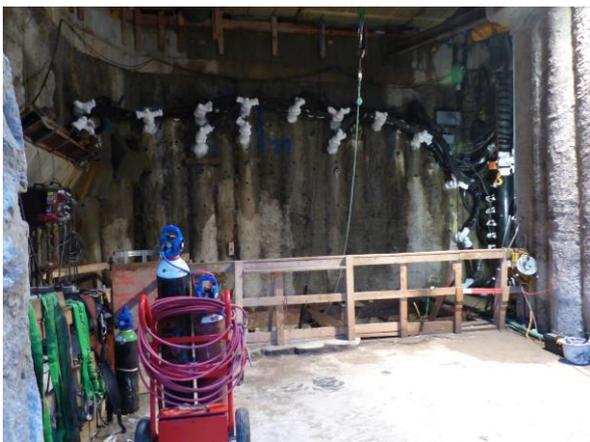
Figure 21: Freezing pipes at the starting point

The tolerance of freezing work/drilling of the freezing pipes on site was 0.5 m radius. The spacing of two freezing pipes is 0.50 m, at the starting point and it was not possible to reduce the spacing at the starting point in the secant piles (see figure 21). If the spacing between two pipes in the soil was more than

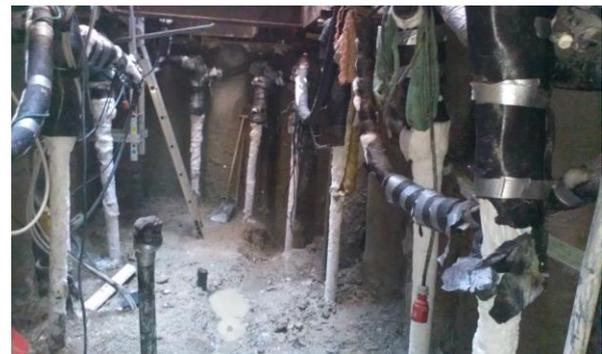
The vertical freezing pipes had to be very close to the secant pile wall (see figure 23). Therefore, the pit layout including the capping beam had to be designed such that all stages of the construction pit were possible. Furthermore, there had to be enough room for the drilling machine to work, even though the pit was narrow in the deep part. The drilling rig distance to propping systems had to be about 30-40 cm; otherwise it was very difficult to carry out the drilling work.

Figure 23: Vertical freezing pipes close to secant piles
