Effects of soil-structure interaction on the excitation and response of RC buildings subjected to strong-motion

J.Th. Snæbjörnsson

ABSTRACT

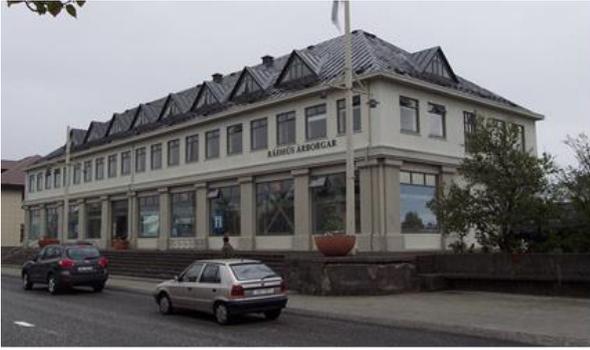
Figure 3 The Town Hall at Selfoss, view from NE.

The Town Hall at Selfoss (see Fig. 3) is a cast-in-place reinforced concrete building with 3 stories and a basement. It is about 11 m high from ground level to the rooftop, and about the same distance from the basement floor to the top floor, with the basement reaching 4 meters below ground level. It is rectangular in plan, about 41 m long (east-west direction) and 13 meters wide (north-south direction). The structural system is composed of outer shear walls a shear core and two rows of interior concrete columns and interconnecting floor beams that carry the slabs. The orientation of the building is such that the length of the building approximately aligns along an ESE-WNW axis. The building was renovated and retrofitted in the period of 1997 to 2001.

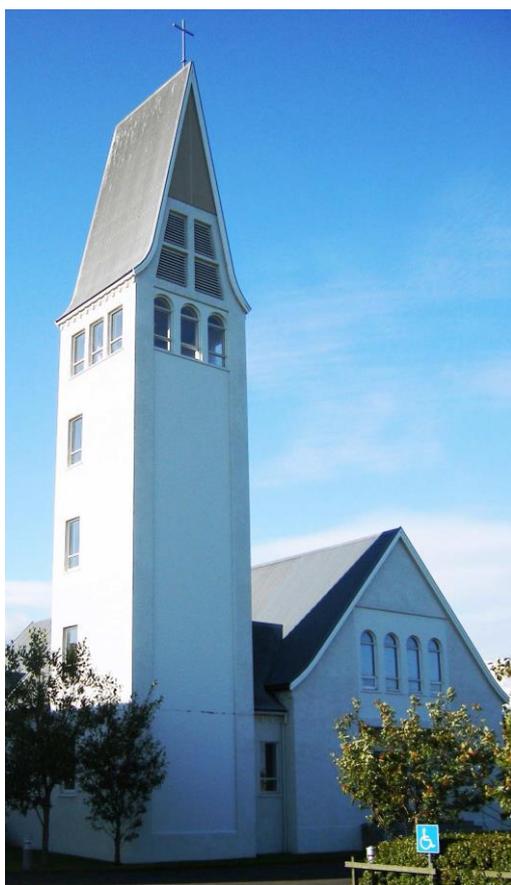
Figure 4 The bell tower of Selfoss church.

The bell tower of the Church of Selfoss is a square 4 m by 4 m cross section, see figure cast-in-place, reinforced concrete shear wall building (see Figure 4). It is approximately 23 m high, making it one of the tallest building in Selfoss. The tower is connected to two small adjacent buildings, of an approximately 7 m in height on the North and the East side.

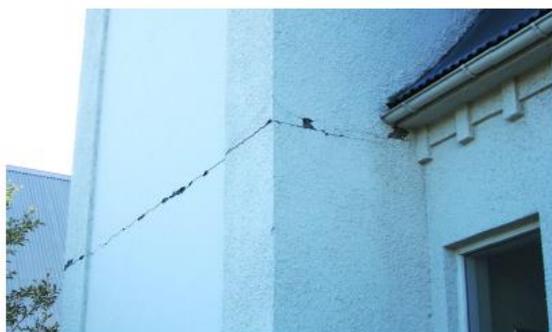
Figure 5 The crack in the Bell tower.

During the earthquake a fracture opened through the entire perimeter of the tower, see Figure 5. The fracture opened both on the outside of the tower as well as on the inside. The location of the crack is at the height of the adjacent buildings, i.e. at about 7 m from the ground. This location is vulnerable due to abrupt changes in the stiffness of the tower at

this height, but also there was also a construction joint at this level.
