Experiences of integrated GPR and Laser Scanner analysis – We should not only look down but also around

Timo Saarenketo, PhD, adj.prof., CEO
Roadscanners, Finland, timo.saarenketo@roadscanners.com

ABSTRACT

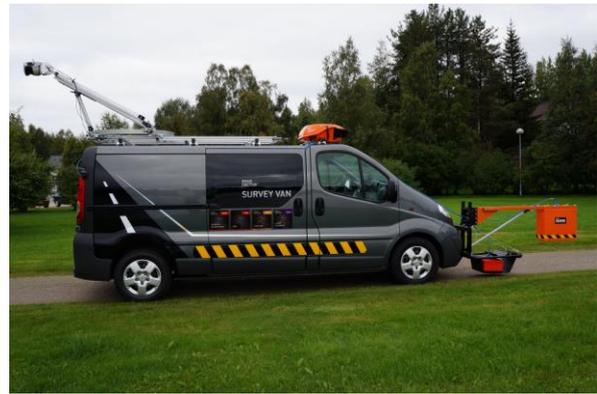
Figure 1. Road survey system equipped with ground penetrating radar system (in front) and a 2D laser scanner (at the back).

Ground Penetrating Radar systems use discrete pulses of radar energy with a central frequency varying from 10 MHz up to 2.5GHz to resolve the locations and dimensions of electrically distinctive layers and objects in materials. Pulse radar systems transmit short electromagnetic pulses into a medium and when the pulse reaches an electric interface in the medium, some of the energy will be reflected back while the rest will proceed forwards. The reflected energy is collected and displayed as a waveform showing amplitudes and time elapsed between wave transmission and reflection. When the measurements are repeated at herz frequencies (currently up to 1000 scans/second) and the antenna is moving, a continuous profile is obtained across the target (Saarenketo 2006). In addition to pulse radar GPR systems (Figure 1) stepped frequency radar systems are also entering the road survey markets.

A laser scanner is composed of three parts: a laser canon, a scanner and a detector. The laser canon produces the laser beam, the scanner circulates the beam and the detector measures the reflected signal and defines the distance to the target. The distance measurement is based on the travel time of light, or phase shift, or a combination of both. Laser scanner systems can be classified into two types of system: 3D laser scanners that can be used for mobile mapping, and 2D laser that is designed to be used in basic pavement engineering projects (Figure 1) (Saarenketo et al. 2012).

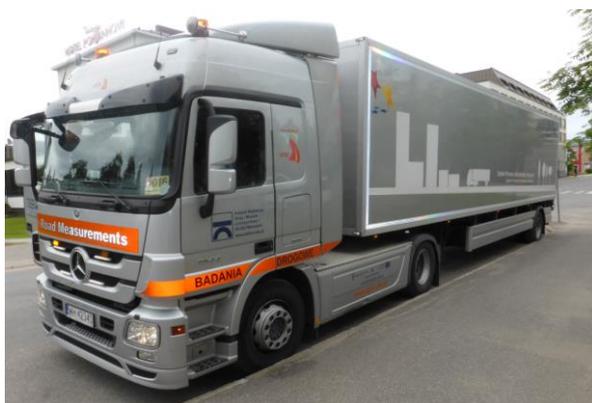
Figure 2. TSD truck used deflection surveys in Finland.

Deflection measurements have a key role in evaluating the structural condition of a pavement structure and the fatigue level of the asphalt. With the help of deflection surveys, it is possible to locate road sections that are still visually in good condition but which will become distressed very soon if appropriate measures are not taken. Traditionally deflection surveys have been carried out with falling weight deflectometer systems but their limitation is that they are point measurement and are traffic intrusive. The new solution for this problem is the traffic speed deflectometer (TSD) (Figure 2) that measures continuous deflections of a pavement under a moving 10 tonne axle load using Doppler sensors. The normal survey speed with this truck is 80 km/h so it does not require any protection during the survey. Deflection bowls similar to FWD can be calculated from the TSD measurements.
