Large scale driving of concrete piles in stiff to very stiff clay

Thomas Sandene

Norwegian Geotechnical Institute, Norway, thomas.sandene@ngi.no

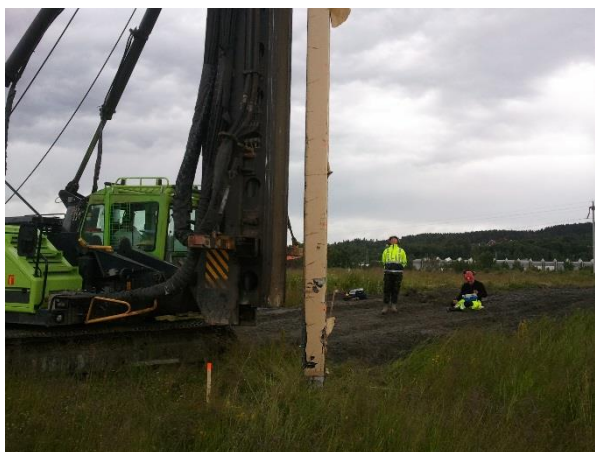
Figure 7: Test piling with PDA-testing

The test-driving was performed in late June and early July of 2012. A total number of 24 P270NA piles and 2 P230NA were driven using a 60 kN hydraulic hammer. The piles were scattered over the construction site, covering different variations in ground conditions. Out of the 26 test-piles, 2 piles broke during driving. The setup of test-piling at the site is shown in Figure 7.

During test-driving, 7 piles were driven with PDA-sensors mounted. The sensors logged the whole driving process of the piles, from terrain and down to stop criteria when hitting either bedrock or moraine layers. This gave an output of the tension stresses in the piles for all blows during the driving history. Results from PDA measurements confirmed previous analysis results that tension stresses were within acceptable range for the piles, and the project could continue with concrete piles as planned.
