Guldborgsund Tunnel. Operation of tunnel and drained ramps

ABSTRACT

The tunnel at Guldborgsund is an immersed tunnel connecting the Danish islands Lolland and Falster. The tunnel is a twin tube road tunnel. The tunnel is approximately 500 m long including portal structures, and has approx. 400 m open ramp on each side of the tunnel. The tunnel is owned and administered by the Danish Road Directorate.

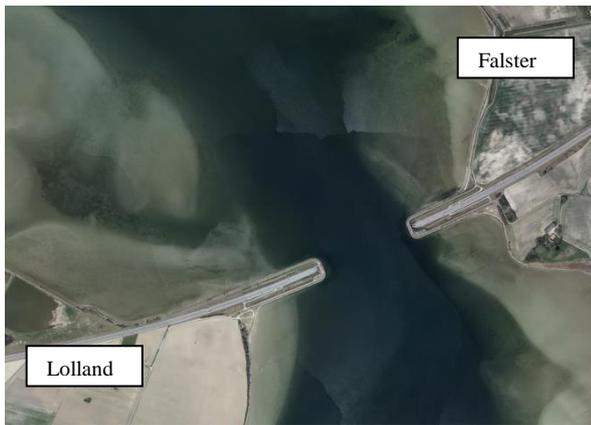
Figure 1.1. Guldborgsundtunnel. Aerial view.

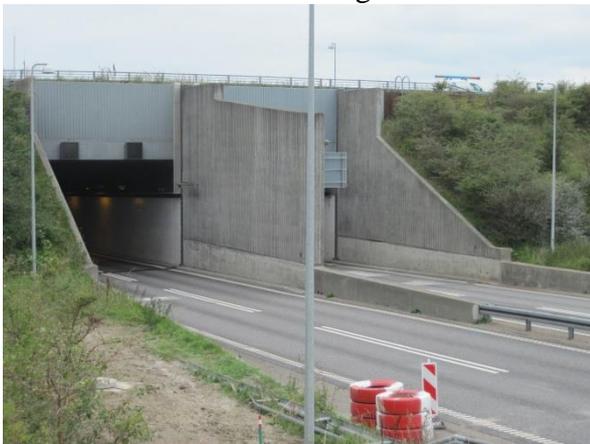
Figure 1.2 Photo from Falster site of tunnel entrance.

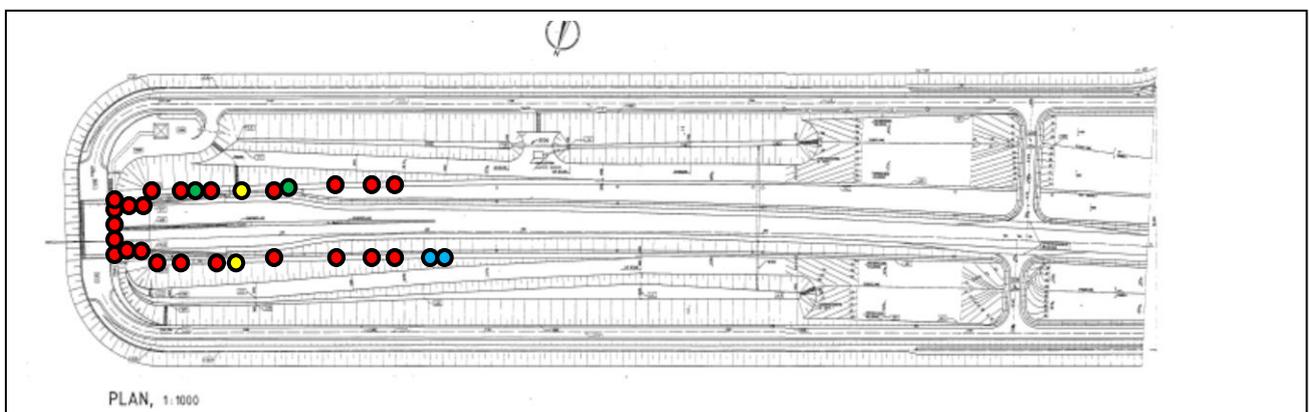
In the open ramps a relief system is established in order to lower the groundwater level in the chalk and on Lolland also in the sandfill. The system is supplemented by longitudinal drains, but it is only on Lolland in the sandfill this system contributes with relevant drainage. The relief system consisted in 1988 of 7 relief wells on each side of the ramp and 10 relief wells in the bottom of the portal structure for each ramp. The wells on each side of the ramp relieved water to a longitudinal collector pipe and the wells in bottom of the portal structure relieved water directly into the portal reservoir. In total 24 wells in each ramp secured the ramp from piping and hydraulic failure. The relief system was placed in the deep part with surface between -6 and -4 m and was and are still able to secure the entire ramp. The system of wells is shown in Figure 1.3.

Figure 1.3 System of relief wells. Overview.

4 new relief wells (marked with yellow in Figure 1.3) were established in the middle of the ramps on both sides.

In 2009 piping was observed in a small local area in the north side of ramp on Lolland and 2 additional relief wells (marked with blue in Figure 1.3) were established.

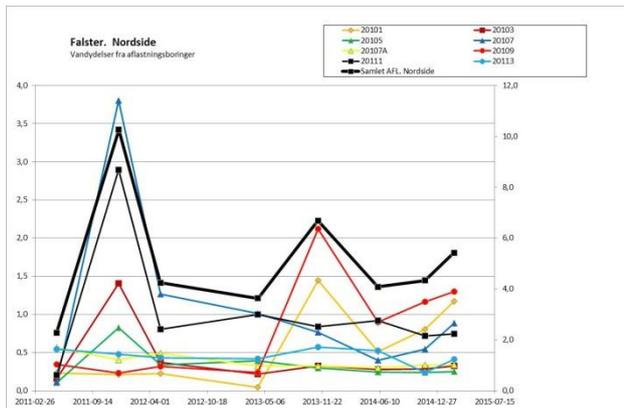
Section 4 comprises an explanation to understand, why we in 2016 can maintain acceptable water level for 25 m³/hours relief, which required 50 m³/hours in 1988. Yield monitoring in single wells are ongoing twice a year and used for selecting relevant wells for reconditioning. Measurements for the period 2009 to 2015 are shown in Figure 1.7 for the relief wells on Falster North ramp.

Figure 1.7 Yield measurements Falster North.

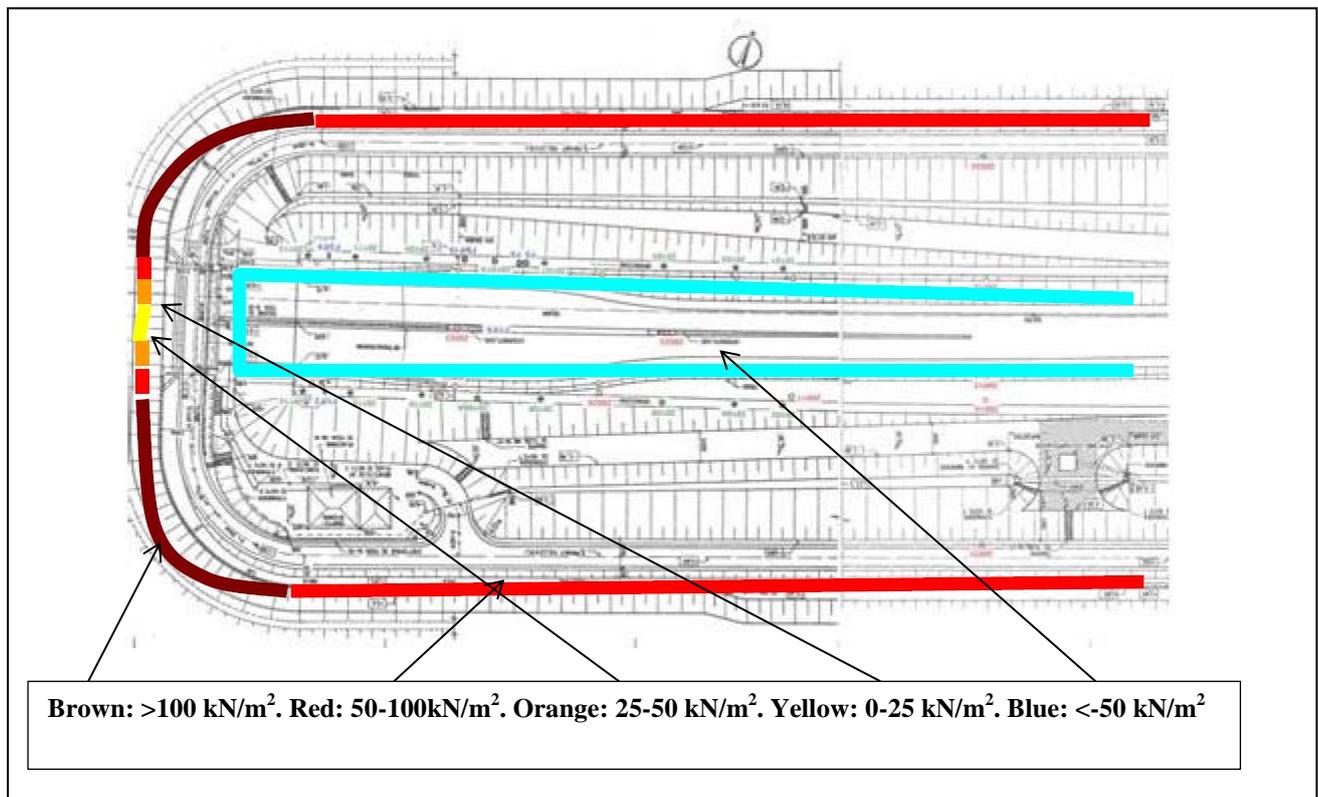
In Figure 1.11 an overview of the increase in effective stresses are established based on groundwater lowering, dike-establishment and gravity structures. Areas marked with brown indicates stress increases above 100 kN/m², red is 50-100 kN/m², orange is 25-50 kN/m² and yellow is below 25 kN/m². The figure is not 3-dimensional correct as effective stresses from dike load and gravity structures will decrease by depth due to spreading and increased stresses from the groundwater relief will maintain the full additional effective stress in the whole aquifer to an unknown depth.

Figure 1.11 Falster overview. Estimated changes in effective stresses.
