Founding on (un)known chalk in Aalborg

C. T. Leth

COWI A/S, Denmark, ctl@cowi.dk

The North Denmark Region wishes to build a new hospital to accommodate all hospital functions in Aalborg. At a budget of DKK 4.1 billion, the complex of buildings will cover 155,000 m². The first turf was cut in 2013 and the construction works will run from 2015 to 2020. The foundation level will vary from approximately four metres to ten metres below ground surface.

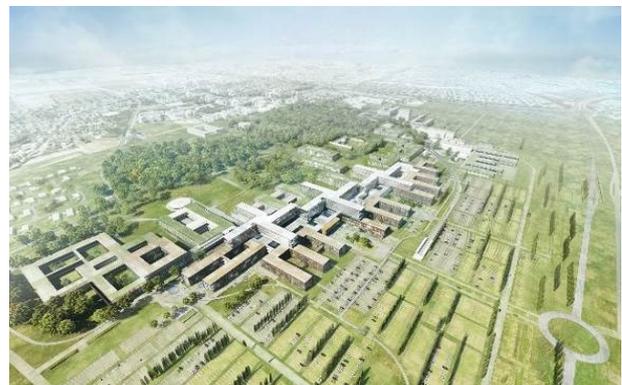
Figure 1: Illustration of Nyt Aalborg Universitetshospital (NAU).

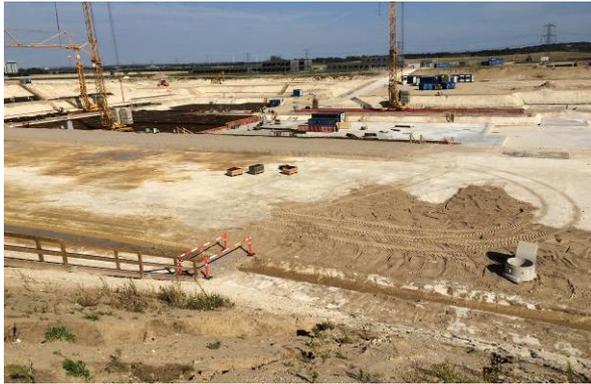
Figure 2: Excavation for basement level K2.

The building is constructed in an open excavation of 250 x 300 m. Existing terrain level varies between level (DVR90) +10 m to +18 m and deepest foundation (basement level K2) is level +2.95 m.

Ground water level is measured as high as +5.5 m and a temporary groundwater lowering is installed consisting of 18 dewatering wells with a yield of approx. 80 m³/h.

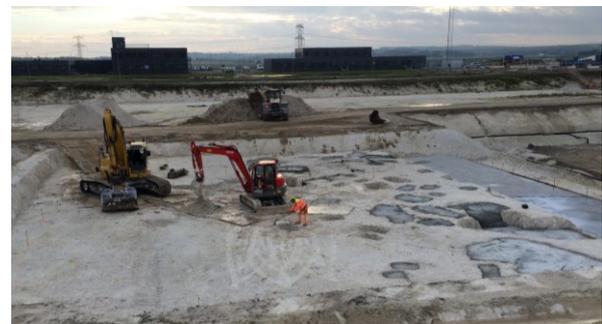
A situation with 'chimneys' at level +6.5 m can be seen at Figure 11. The foundation area consists of a section with many 'chimneys' (right side of photo) and a section without any chimneys (left side of photo).

Figure 11: Excavations of 'chimneys'

Existing terrain level was for the area shown in Figure 11 at +12.0 m with stratigraphic sequence of 1 m topsoil, 1 m glacial meltwater sand and chalk from +10.0 m. One of the 'chimneys' was measured to 400 mm in diameter and 3.1 m in depth, equivalent to bottom level at +3.4 m or approx. 8.5 m below terrain.
