Pore pressure reduction and settlements induced by deep supported excavations in soft clay

J. Langford

NGI, Norway, jenny.langford@ngi.no

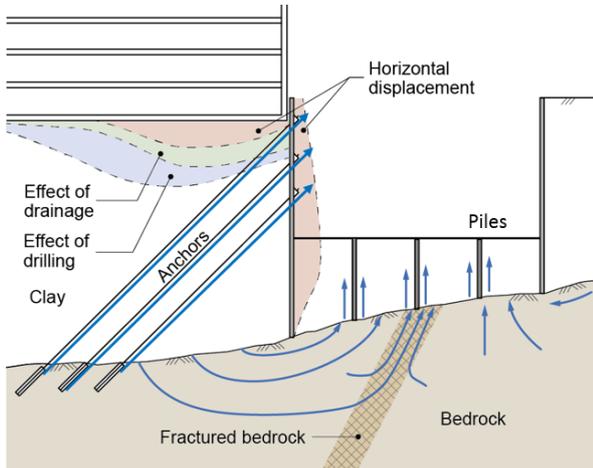
Figure 1 Illustration of the main causes of settlements connected to deep excavations in soft clay.

The main causes of deformation connected to the performance of deep excavations in soft clay are (illustrated in Figure 1):

- Shear-induced ground movements linked to horizontal displacements of the supporting wall

- Leakage causing pore pressure reduction and consolidation settlements, when the effective stress exceeds the preconsolidation pressure
- Installation or "disturbance" effects induced by drilling for tie-back anchors or drilling for piles inside the excavation

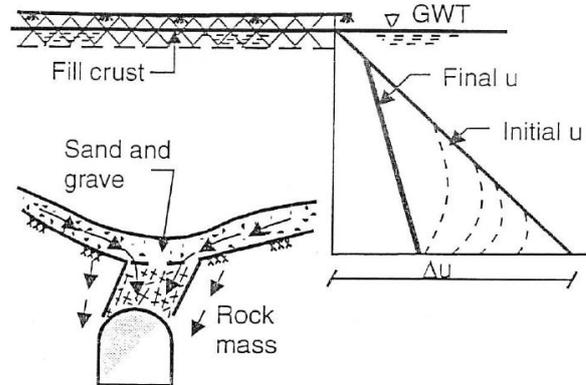
Figure 2 Leakage to bedrock tunnels overlain by clay deposits (from Karlsrud et al., 2003).

Experience from tunnels (Karlsrud et al., 2003) and ground water pumping, shows that small amounts of leakage into a tunnel, can result in substantial decrease in pore pressures at bedrock level (at bottom of clay layer) (Figure 2). The main reason is the very limited recharge that comes through a low-permeable soft clay deposit, which makes the soil or bedrock below act as a confined aquifer. Analysis of data from numerous tunnel projects show that the leakage rate into a tunnel needs to be limited to approximately 3-8 l/m/100 m tunnel to limit pore pressure

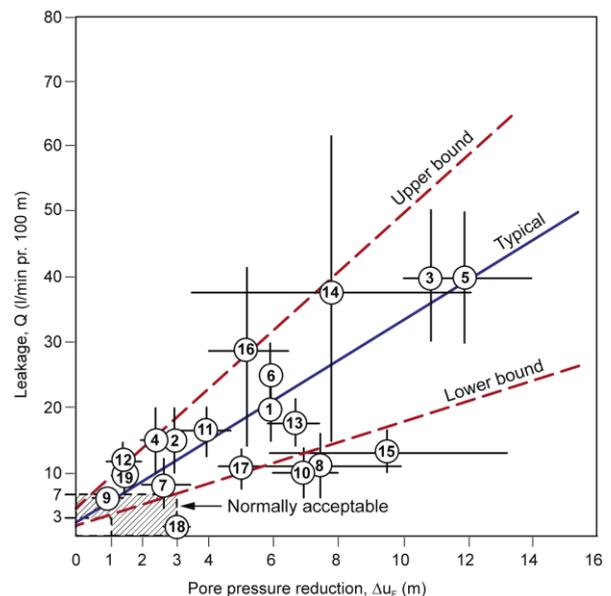
Figure 3 Measured rate of leakage to tunnels plotted against monitored pore pressure reduction at bedrock (from Karlsrud et al., 2003).

decrease to 10-30 kPa at the bedrock level (Figure 3). The data also shows that the pore pressure decrease can extend as far out as 200-400 m from the tunnel (Figure 4).

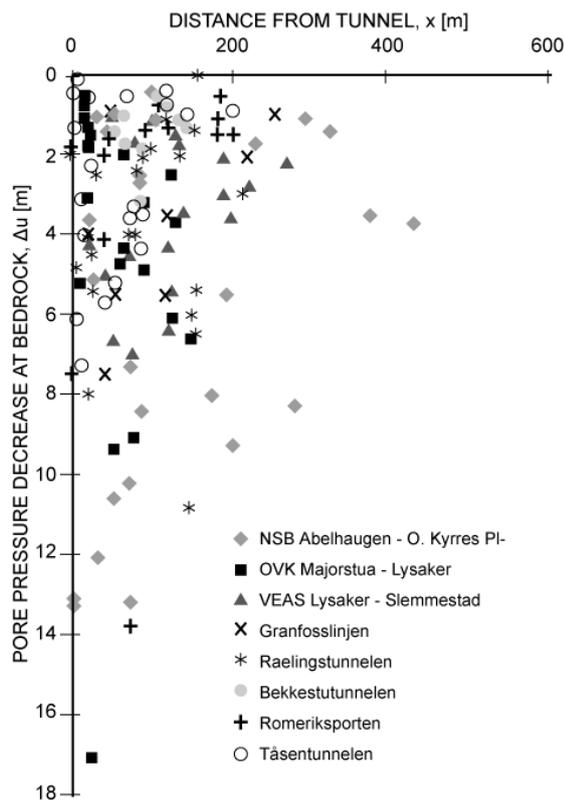
Figure 4 Measured pore pressure decrease at bedrock plotted with distance from excavation (from Karlsrud et al., 2003).

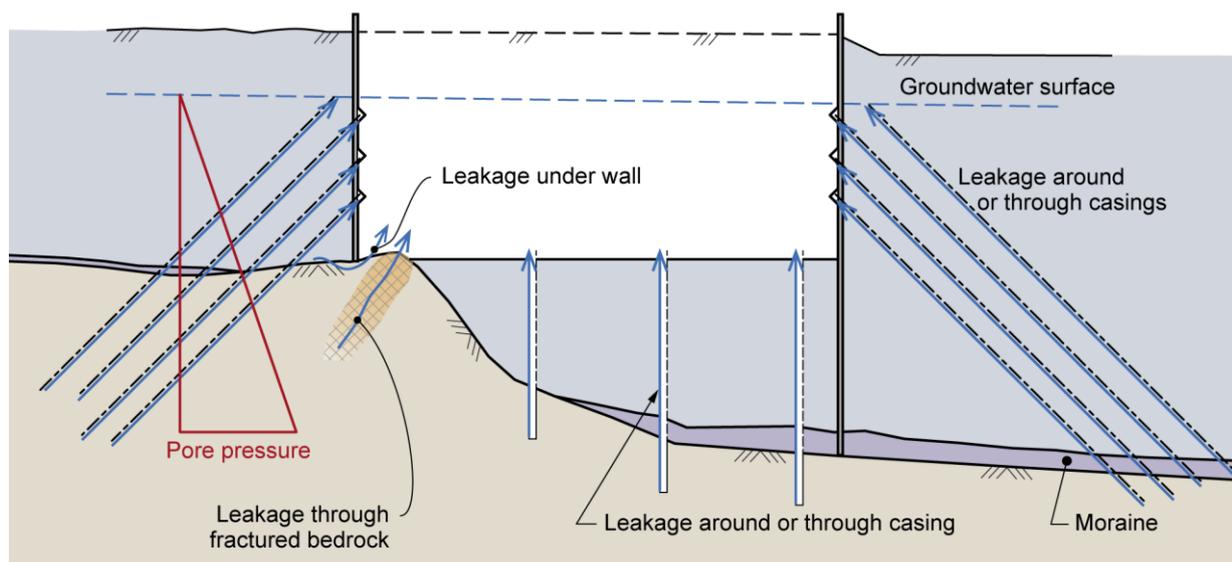
Figure 5 Illustration of possible leakage situations for a deep excavation in soft clay.

- Leakage through the sheet pile wall
- Leakage through gaps between the toe of the sheet pile wall and the bedrock
- Leakage through cracked bedrock
- Leakage during drilling for tieback anchors or piles (through the casing or the gap between soil and casing)

Leakage through the sheet pile wall mainly occurs during the cutting of holes for drilling of tie-back anchors. In addition, leakage can occur through unsealed or poorly sealed locks between the individual pile sections. If the depth of the excavation reaches the bedrock level, resulting in an uncovered bedrock surface, there is a large potential for leakage through fractures. Uncovering the toe of the sheet pile wall also cause a large potential for leakage, especially if the bedrock surface is steep and there is a permeable soil layer on top of the bedrock. Drilling for installation of piles and tie-back anchors has a potential for leakage when performed from a level below the ground water level or under artesian conditions. The leakage can occur through the gap between the installed steel casing or through the casing itself.

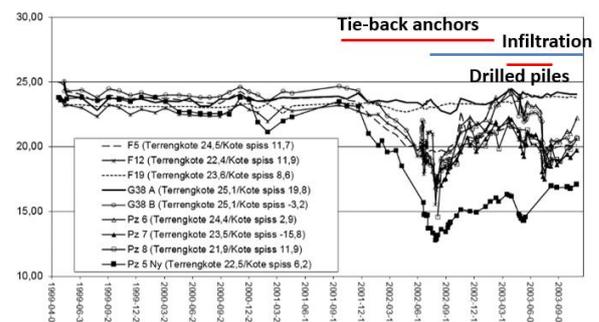
Figure 6 Monitored pore pressure levels and type of construction activities (Braaten et al., 2004).

The results from the case study has previously been reported in Braaten et al. (2004). As the excavation proceeded and drilling for anchors was undertaken, considerable pore pressure decrease, amounting to almost 10 m pressure head, at bedrock was observed. Monitored pore pressure levels over time are shown in Figure 6. Infiltration wells were installed, which resulted in stabilisation of the pore pressure levels. However, as the drilling for steel core piles started, the pore pressures decreased further.

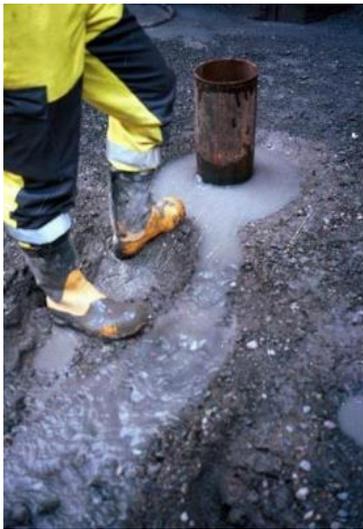
Figure 7. Observed leakage around drilled casing for steel core piles (Jernbaneverket, Jong-Asker).

Significant leakage was observed between the casing for the tie-back anchors and the sheet pile wall, as well as on the outside of the casings for the steel-core piles (Figure 7). The leakage through the casings was stopped by injection of cement in the bedrock. The leakage around the casings were difficult to manage. It increased rapidly and eroded fines material. The leakage decreased after several rounds of grouting with cement suspension and polyurethane grout.

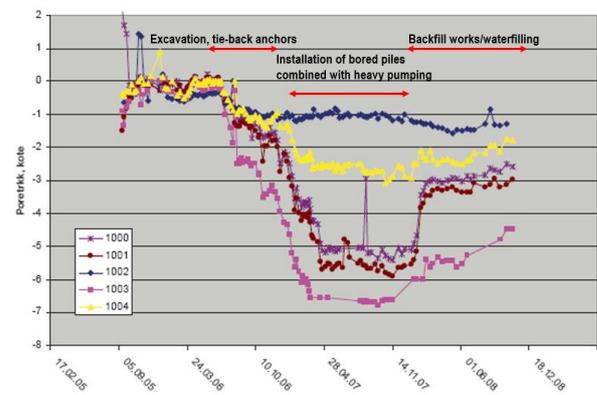
Figure 8 Observed pore pressure levels for first section in case study 2. (Modified after Johansen et. al., 2008 and vegvesen.no).

Results of monitored pore pressures at bedrock level in the main section are presented in Figure 8. Pore pressure measurements indicate that pressures at bedrock level corresponded to level 0 to -0,5 before the excavation was started. The pore pressure at bedrock decreased with 1 m during the excavation and the installation of tie-back anchors. It decreased further to a level of -7 m during the period for installation of steel core piles. The work was performed in combination with considerable pumping, to keep the pit dry. The pore pressure increased as the base slab and walls were cast and material was backfilled.

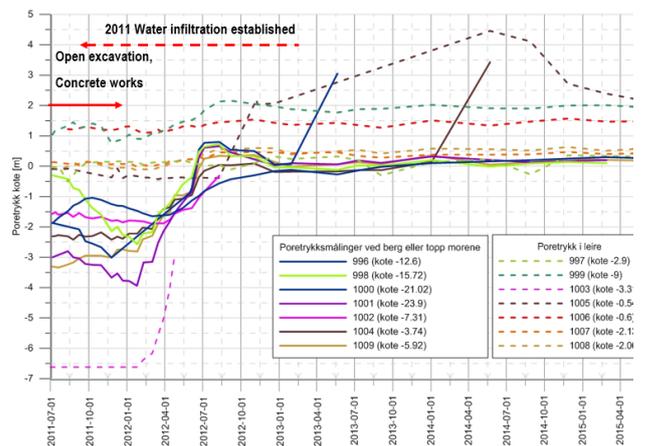
Figure 9 Observed pore pressure levels at the end of phase 2 in case study 2. (Modified after Hauser, 2015 and vegvesen.no). Water infiltration into the bedrock was started in 2011.

of 0. Therefore, it was decided to install wells for water infiltration to reduce the risk of settlements on the surrounding areas and buildings. Figure 9 show the pore pressure levels at bedrock at the end of the excavation, as well as the effects of water infiltration into the bedrock. The figure also shows that the pore pressure in the clay is not yet affected by the drainage except for one piezometer.

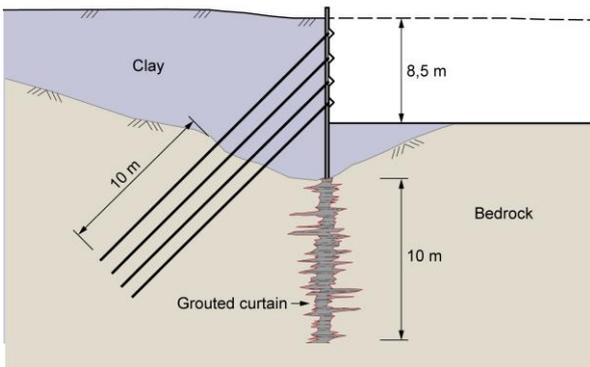
Figure 10 Cross section of case study 3.

This was an extensive excavation in Oslo over an area of about 100 m × 100 m. The excavation was performed to a depth of about 10 m, 8 m below the ground water level. The excavation was supported by a sheet pile wall installed to bedrock, and supported by 1 to 5 levels of tie-back anchors to bedrock. The foundation of the building consists partly of shallow foundations on the bedrock and partly of drilled steel core piles. A typical cross-section of the excavation is shown in Figure 10.

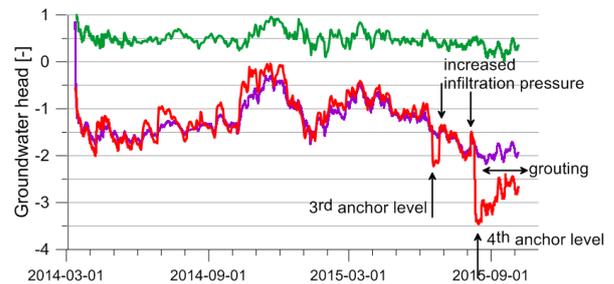
Figure 11. Monitored pore pressure levels and infiltration

shown in Figure 11. Pore pressure measurements indicate pressures at bedrock level corresponding to level +1 to -1 before the excavation was started. The monitoring data shows that the pore pressures at bedrock level started decreasing during drilling of anchor level 3 and 4. During drilling for the anchors leakage was observed, especially between the sheet pile wall and the casing for the anchors, but also through the casing itself. This has been the main cause of pore pressure lowering. An example is shown in Figure 12.

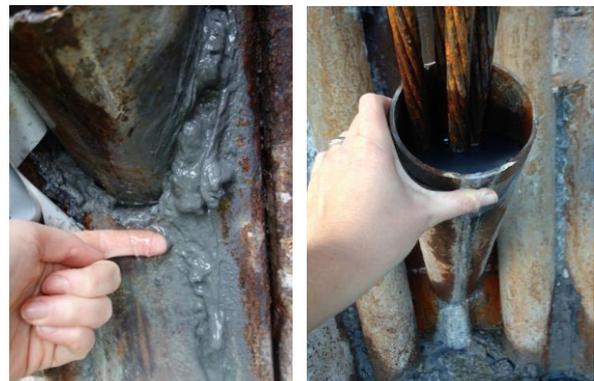
Figure 12. Example observed leakage in connection with installing tie-back anchors.

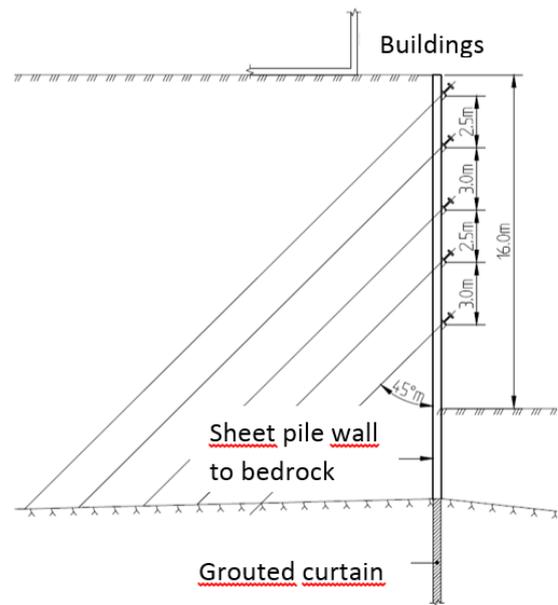
Figure 13 Typical cross section case study 4.

The soil conditions consisted of fill over 1-2 m dry crust clay over normally consolidated soft clay to bedrock, at 10 to 30 m depth. Beneath 8 m depth, the clay was quick. The foundation consisted partly of drilled steel core piles and partly of shallow foundations on bedrock. In addition, tension anchors were installed into the bedrock to prevent uplift. A typical cross-section of the excavation is shown in Figure 13.

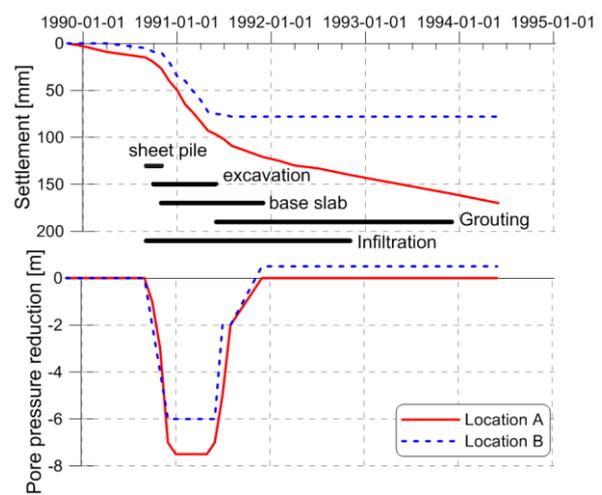
Figure 14 Monitored pore pressures and settlements at two locations.

Some results of monitored pore pressures at bedrock level and settlements are shown in Figure 14. Pore pressure measurements indicate that the grouting and infiltration was effective measurements. The pore pressures

recovered and the settlement rate was decreased to the same levels as before the excavation started. Other important measurements were consistent use of packers in every borehole, where leakage was observed, both for drilled anchors and drilled piles. Furthermore, additional infiltration wells were installed through the sheet pile wall.

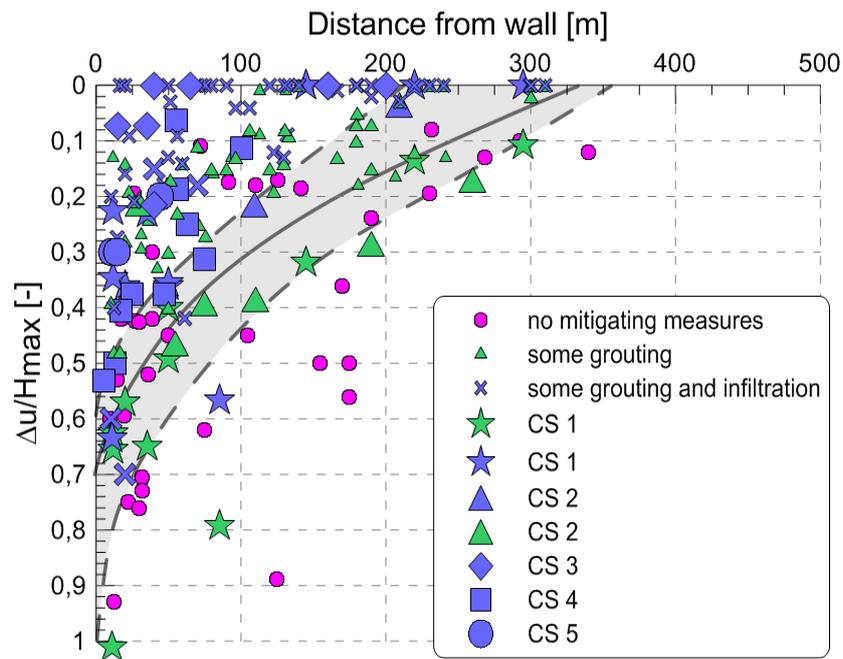
Figure 15 Observed normalized decrease in pore pressure at base of clay layer as function of distance from the excavation based on case records from Norway

together with previously published data from Braaten et. al (2004), Johansen (1990) and Karlsrud (1990). The results are shown in Figure 15. In the plot, the measured pore pressure reduction at bedrock level, Δu , is normalized with respect to the depth of the excavation below the original ground water surface, H_{max} . The data are plotted against the horizontal distance of the piezometer from the excavation. The data from the five case studies are labelled CS1 to CS5.

Red symbols show cases where no grouting or recharging (infiltration) of water was undertaken, green symbols show cases where some grouting at the toe of the wall and into bedrock was undertaken, and blue symbols represent cases where some grouting as well as infiltration was undertaken.

The figure suggests that even when performing systematic grouting and infiltration, the maximum pore pressure reduction close to the excavation could correspond of 20-50% of the depth of the excavation below the groundwater level. Furthermore, a reduction can be extend as far as 300-400 m laterally from the excavation. It can be concluded that it is challenging to maintain the pore pressure levels, even when mitigating measures are undertaken.

Dashed lines in the figure indicate which range pore pressure drawdown can be expected. It is important to note that the lines are rough estimates. The lower bound could be applied for cases where both infiltration and grouting is performed, and the higher bound can be taken as a worst-case scenario where no mitigating measures are undertaken.
