Seismic Response of Squat Walls Founded on Gravel Cushions

ABSTRACT

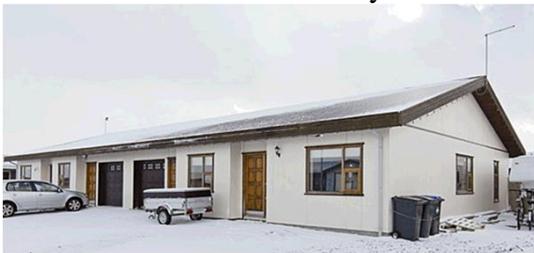
Figure 5: Typical squat wall structure in the SISZ.

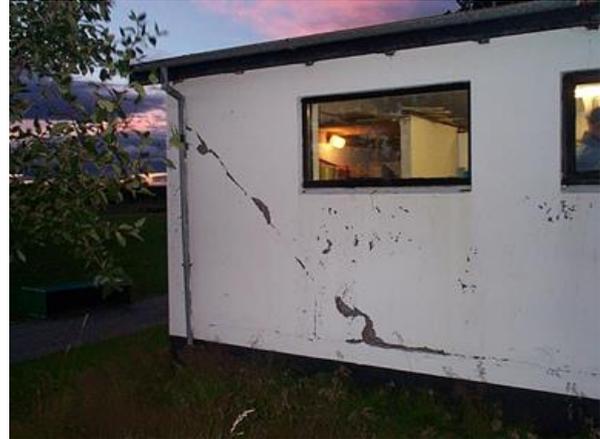
Figure 6: Damaged squat wall in Hveragerði after the 2000 earthquake with visible shear crack.
