Is it reasonable to reduce the shaft resistance for bored cast-in-situ piles?

Jannie Knudsen
COWI A/S, Denmark, jahs@cowi.dk

The expansion of the Køge Bay motorway involves construction of a new bridge (Bridge no. 79.80). The bridge is an underpass of a new railway line below the existing motorway, and the bridge shape required the establishment of a middle support.

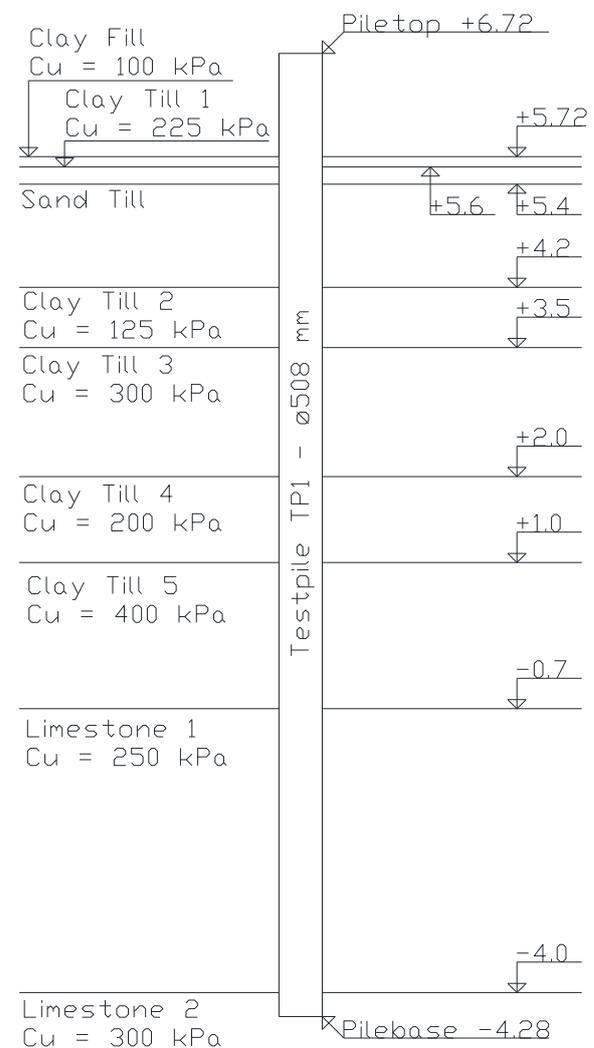
Figure 2 Geotechnical borehole no. J102.

Uppermost in the geotechnical borehole is 0.8 m of clay fill, beneath which there are glacial deposits, primarily consisting of clay till down to the top of the limestone at level -0.7 m.

Locally within the clay till, there is observed a 1.2 m deposit of sand till from level +5.4 m to +4.2 m.

Flint layers have been encountered in the limestone.

The primary groundwater level is measured at level +2.9 m in a screen positioned in the limestone.

For bridge no. 79.80 at Køge Bay motorway, geotechnical investigations were carried out and reported in the geotechnical investigation report by Rambøll (2014). The test pile was established near geotechnical borehole no. J102, see Figure 2.

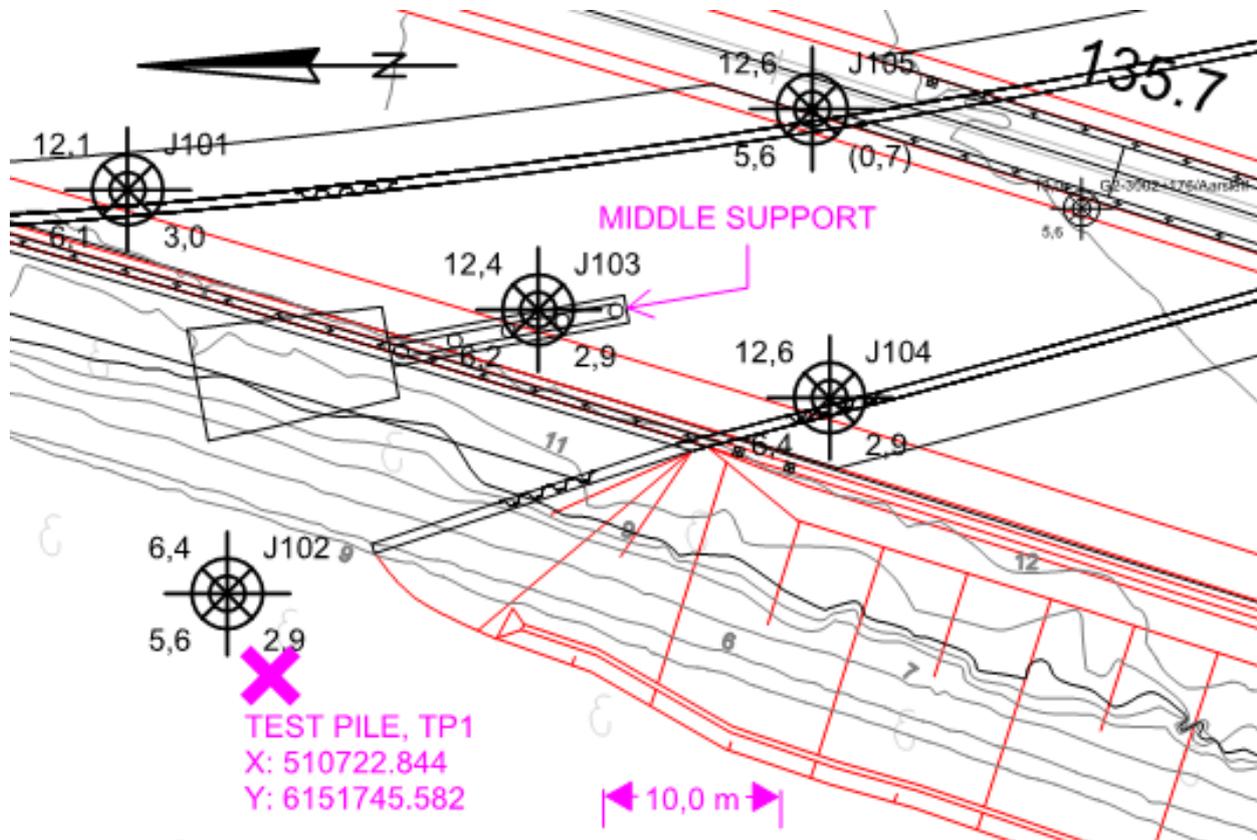
Figure 3 Illustration of middle support, test pile TP1 and geotechnical borehole no. J102.

The test pile was established as close as possible to the middle support and near a geotechnical borehole (Borehole no. J102). See Figure 3.

The test pile was established using a Ø508 mm casing, and a Ø350 mm auger for drilling inside the casing. The first 5 m of the test pile was drilled using a Ø500 mm auger to establish a stable hole for the casing, and the deepest 1 m of the test pile was drilled using a Ø400 mm hole saw in order to ensure the best clean-up possible for the bottom. Dimensions of the test pile are shown in Table 1:

The middle support is a contiguous pile wall designed with 15 pieces of Ø880 mm concrete piles cast with a pile spacing of 760 mm. Consequently, the pile wall measures 0.88 m in width and 11.52 m in length. The piles above ground level are finished with a concrete cover, giving the final wall a width of 1.2 m and a length of 12.1 m.

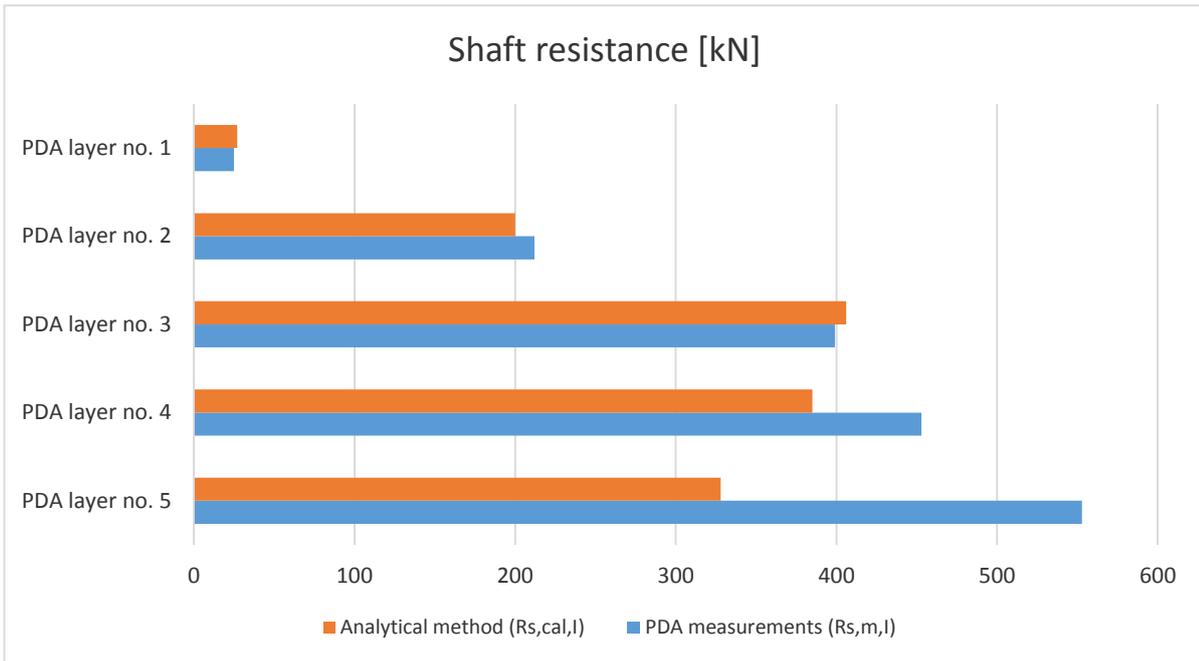
Figure 5 Bar chart showing shaft resistance from analytical method and PDA measurements, respectively.

In Figure 5 and Figure 6 the shaft resistance and base resistance from calculations and

PDA measurements are shown in bar charts.

The results listed in section 6 clearly shows that both the actual shaft resistance and the actual base resistance demonstrated by the PDA measurements are larger than those indicated by the representative calculation carried out for a similar driven pile based on the analytical method.

Regarding the shaft resistance, it is seen that the assumption regarding partial contact between pile and soil at the upper 3.2 m of the pile, due to the casing left behind, was correct.

The shaft resistance in the clay till from level +2.52 m to level -0.7 m shows good correlation between the analytical method and the results from the PDA measurements.

Finally, it is seen that the strength parameters in the limestone from level -0.7 m to pile base at level -4.28 m were significantly underestimated by the conservative estimate, because the actual shaft resistance demonstrated by the PDA measurements significantly exceeds the shaft resistance derived from the analytical method.
